## DEVELOPMENT APPLICATION

| <b>PROPOSED DEVELOPMENT:</b> | Pergola and deck (Residential) |

## LANDSLIP RISK ASSESSMENT

Alterations & Additions - Residential Dwelling

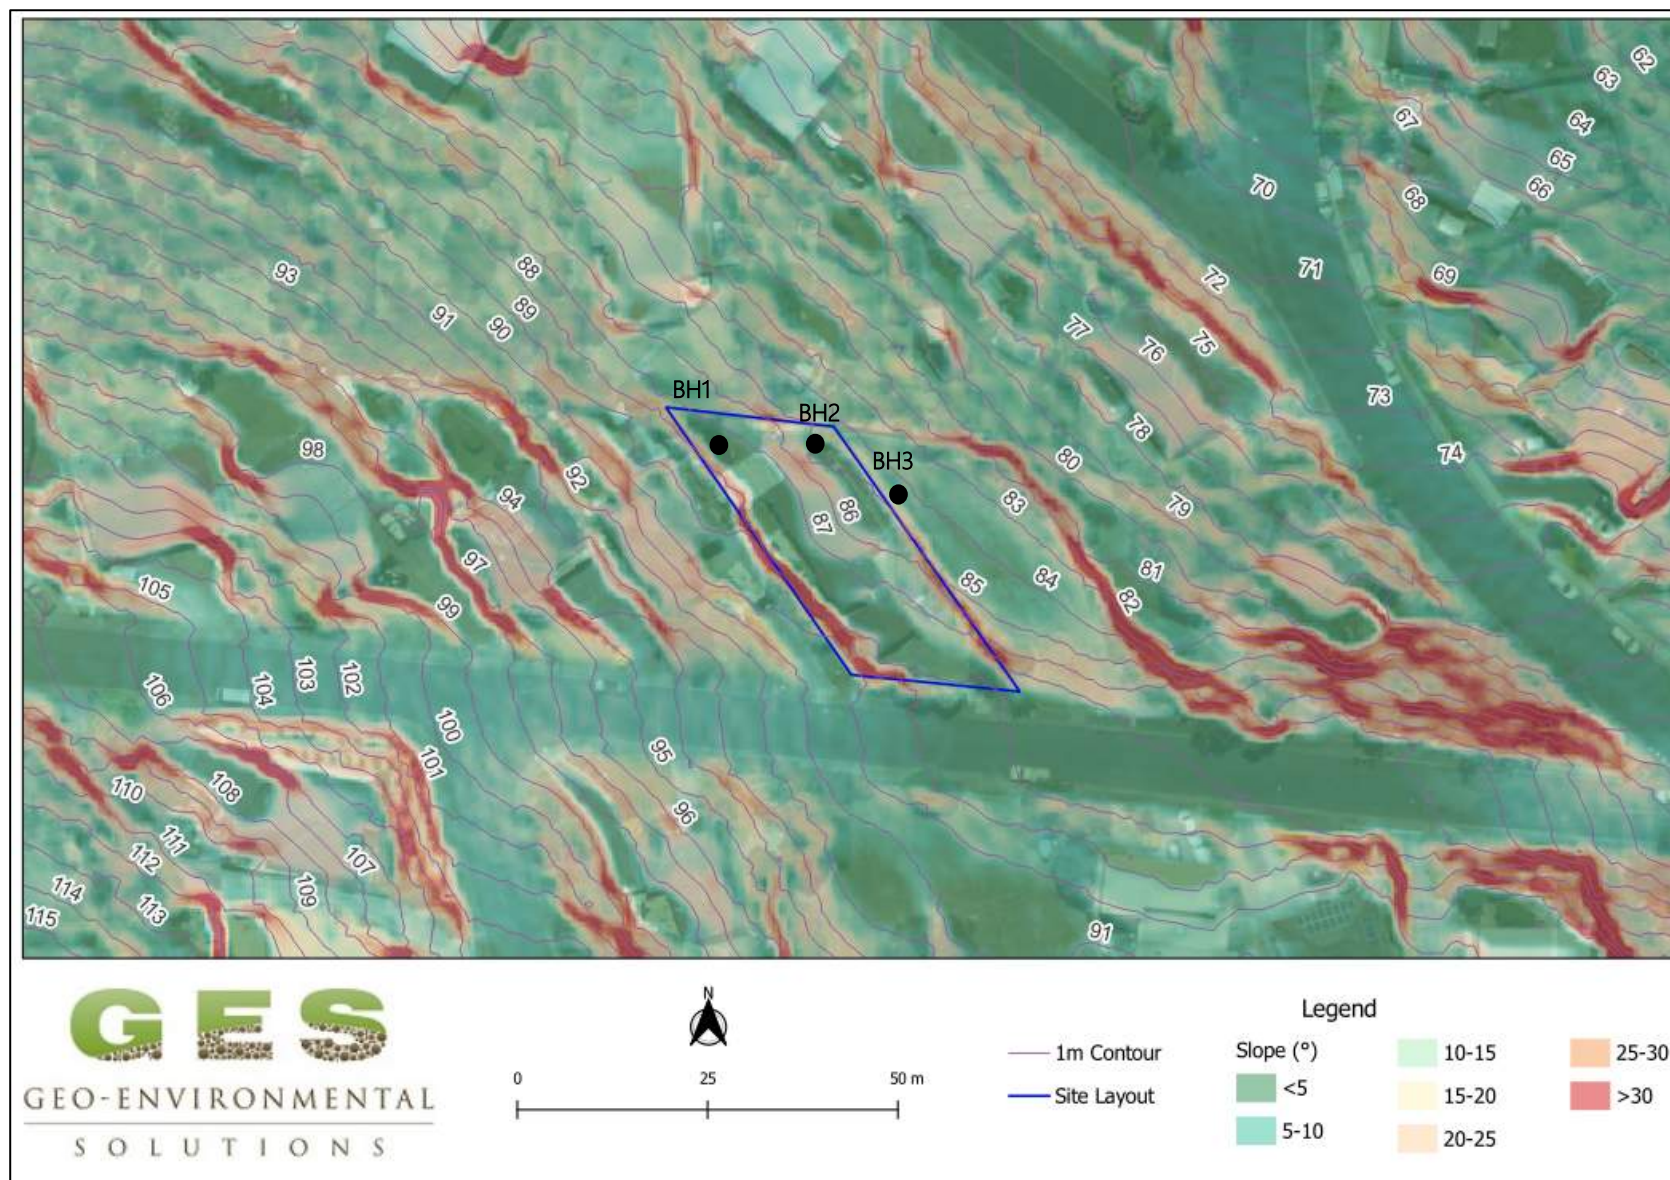
Figure 5 - Slope model developed from Hobart 1m-2013 LiDAR data (borehole approx. locations in black)

The dwelling is positioned on northeast facing slope. The development occupies the area situated along the northern and western portion of the site. Elevation on the site is approximately at 90 meters above the Australian Height Datum (AHD) at the south east portion of the site and 84m AHD at the north east portion of the site. The dwelling sits on gentle slopes, exhibiting gradients between 5 to 10 degrees with a steep cut in excess of 30 degrees along the western boundary shared with 8 Officer St. To depict the onsite slope angles, a slope gradient map was generated using QGIS software and 2013 Greater Hobart LiDAR data (refer to Figure 5).

A site visit was undertaken on 5<sup>th</sup> of July wherein three bore holes were completed to identify the distribution and variation of the soil materials at the site. Due to access constraints, boreholes were drilled via hand augering methodology at BH01 and BH02 locations and via ute mounted GeoProbe rig at BH03 location accessed via adjacent lot at 4 Officer St. Table 2 provides a summary of the ground conditions encountered in BH01 to BH03 (refer Figure 5 for approx. locations).

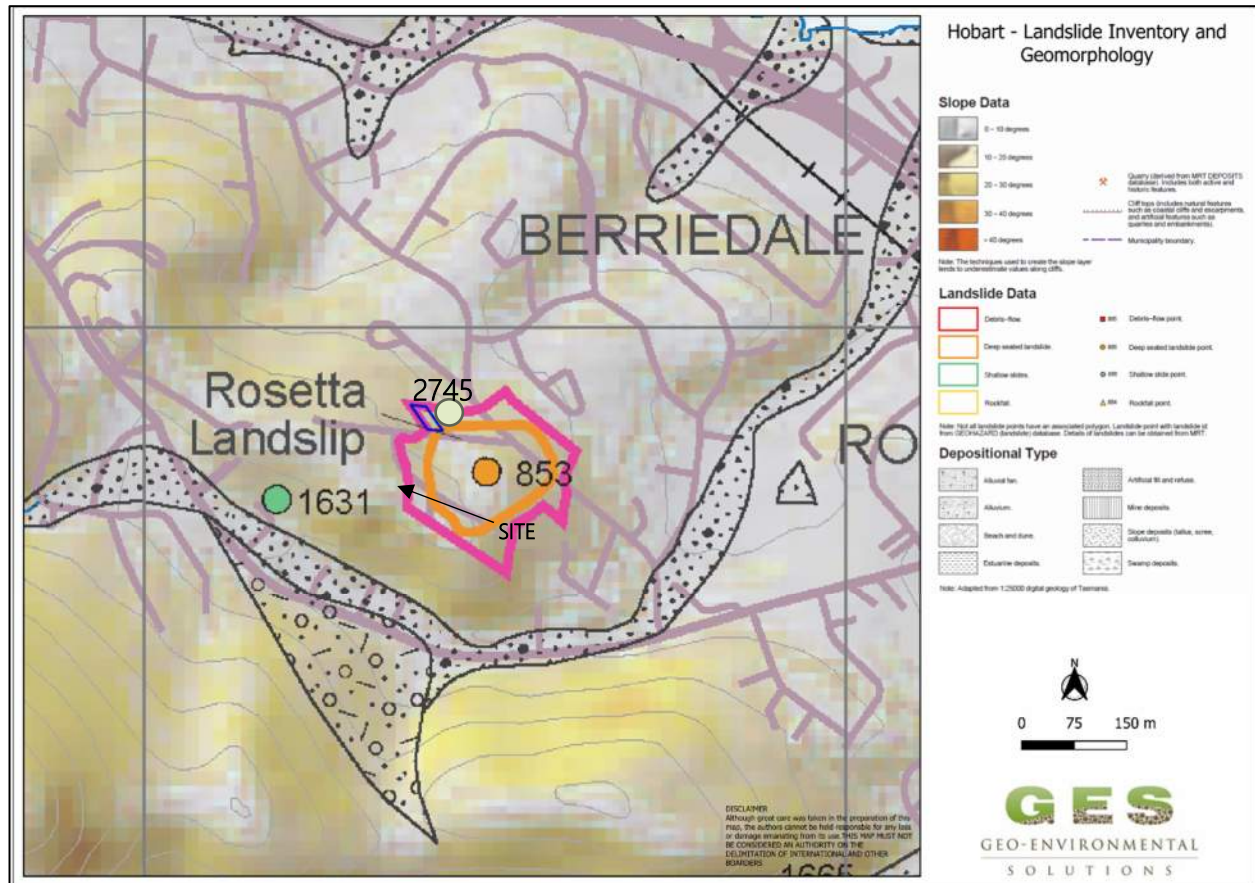
Figure 6 – Hobart landslide inventory map (Mazengarb 2004) overlay within the site (layout shown in blue)

The MRT mapping shows the site to be located on an active earth translational slide (deep seated) with coastal deep-seated slides to the north and south of the site. The head scarp of the Taroon landslide is located approximately 200 m west of the site following the alignment of the Channel Highway. The site itself is located on the southern flank of the landslide. (Figure 6). Table 3 presents a summary of landslides, within similar geological and geomorphological settings to the site.

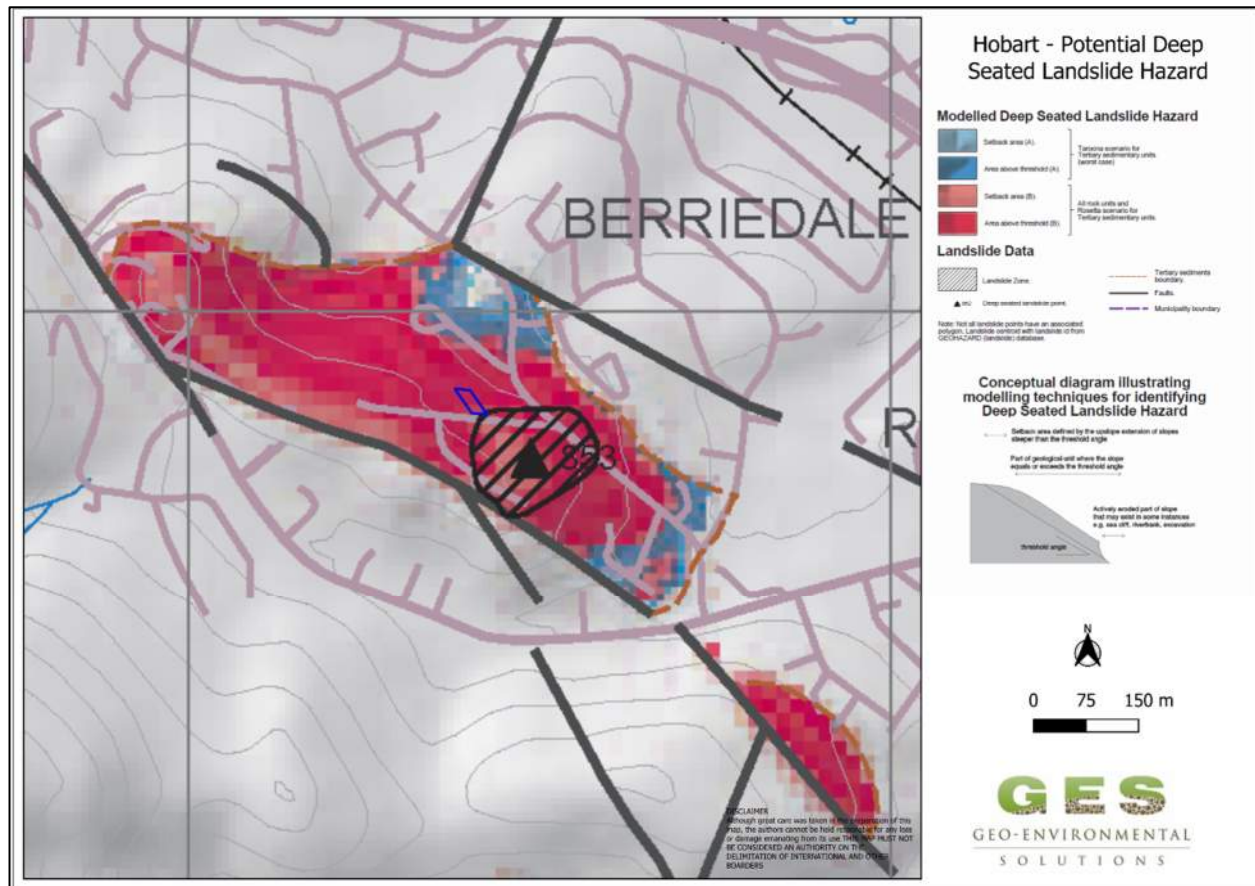
Figure 8 – Hobart deep seated landslide susceptibility map (Mazengarb 2004) with overlay of proposed development (in green) within the site (layout shown in red)

Deep seated slope instability has been identified based on the underlying geology and the slope angles in and around the vicinity of the site (refer Figure 7). The development area on site has been classified by MRT as 'Area above threshold (B)', which is based on a threshold angle of 10° for Tertiary Sediments (based on tertiary sediments encountered at Rosetta).

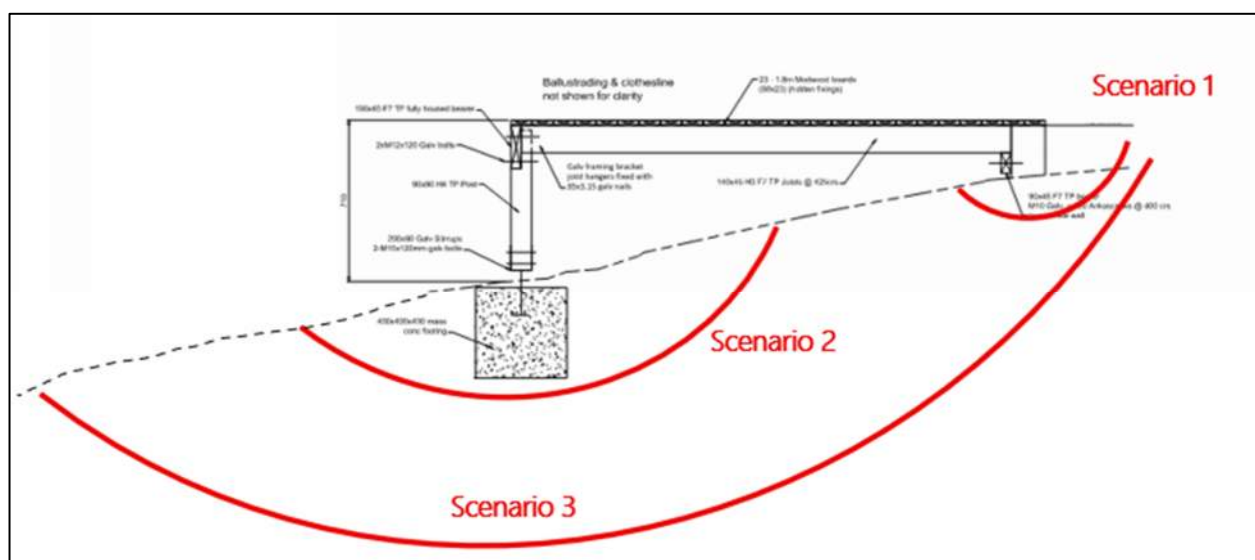
Figure 9 - Conceptual Cross Section of Slope Failure Mechanism relevant to the site (Not to scale)

Based on the slope characteristics including site geology, slope geometry and slope angles, MRT Landslip mapping/inventory and site observations, the following scenarios have been identified as potential slope failure mechanisms for the site (Figure 9):

- **Scenario 1** – Shallow translational slide failure within shallow residual soils in cuttings above the retaining wall (<1.0m high) separating the pergola area from the deck area.
- **Scenario 2** – Shallow translational slide within natural soils and fill materials caused by loading of natural soil slopes below the retaining wall
- **Scenario 3** – Re-activation of part, or all of the assumed fossil landslide on which the property exists due to construction of pergola and deck on site.
