26 August 2022

My Ref: BG-296-220826-Rpt26-DRAFT

Glenorchy City Council

REVIEW OF LANDSLIDES FOR GCC
REPORT 26 – 28 August 2022

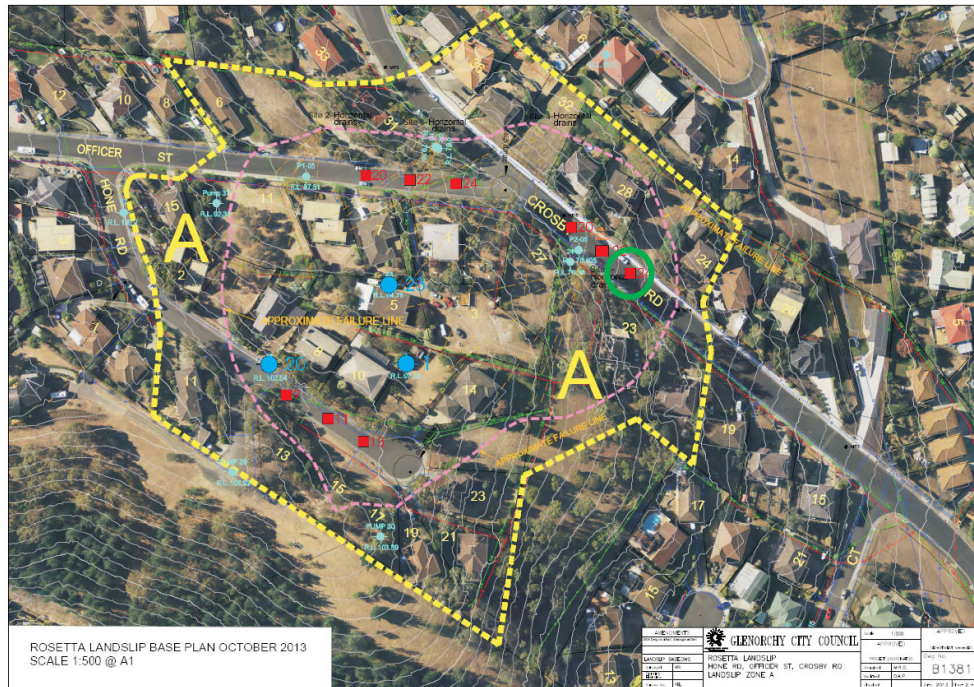
Figure 1 Critical survey monitoring points (in red) and groundwater monitoring boreholes (in blue). Point 24 circled in green.

The last survey was in May 2022. There appears to be a long term trend of settlement and lateral displacement of between 10 and 15 mm over the last 10 years in this area with survey point 24 showing possibly 15 to 25 mm settlement over the same period. There is no significant movement of the landslide but these slight ongoing movements that affect Officer Street, particularly those movements around point 24, continue to require careful consideration and are discussed below in Section 4.

The slight ongoing movements that affect Officer Street, particularly those movements around Point 24 (circled in green in Figure 1) have been of minor

concern for some time. Site inspection suggests that these movements result from the proximity to the toe of the landslide and the seepage in the gutter, where further movements are more likely. The observed movements should continue to be monitored and may be reduced by dealing with the seepage issue.

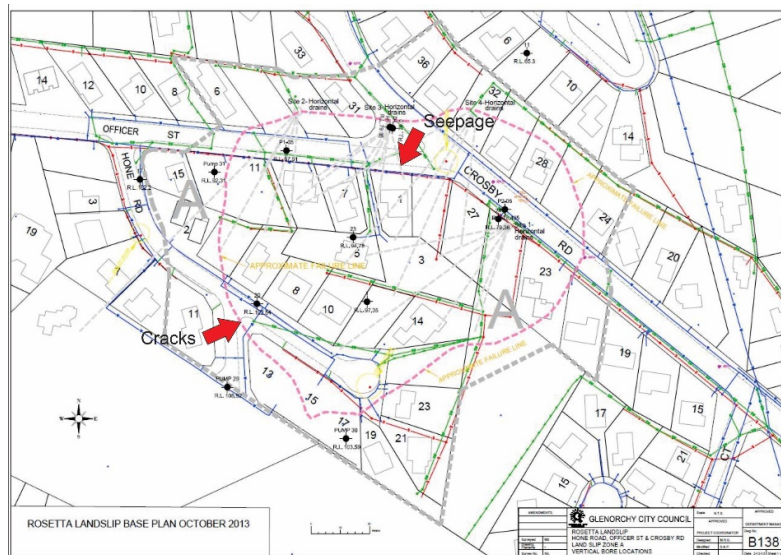
A thorough walk-over survey was carried out at the Rosetta Landslide. Nothing untoward was observed apart from some cracks that needed sealing and some seepage – see Figures 2, 3 and 4 below.

Figure 2 – location of some observations

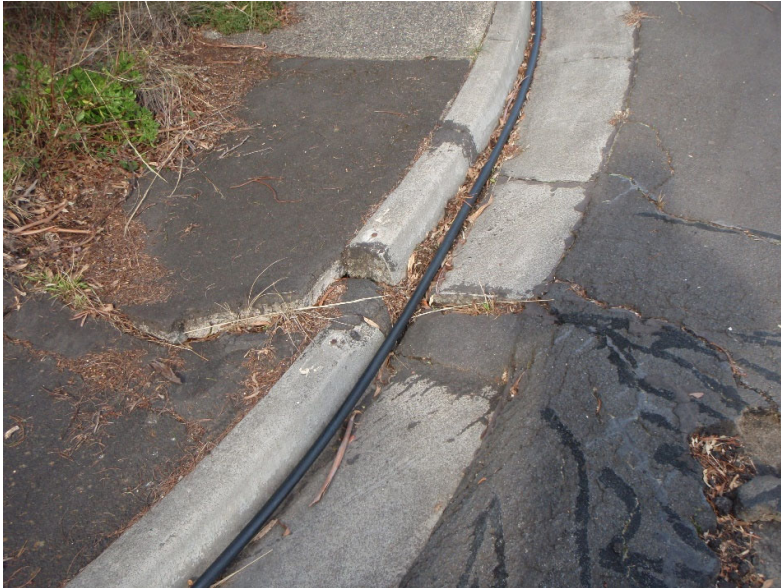
Figure 3 – cracks continuing to open up in the kerb in the cul-de-sac above Hone Rd - see Figure 2 for location.

1. All significant open cracks in paving and asphalt should be sealed with bitumen during the next maintenance campaign.
2. The source of the seepage in Figure 4 should be investigated – perhaps with a camera inspection of the drain. The aim should be to establish the source of the water seepage and if it is due to an identifiable leak then steps should be taken to prevent further leakage.

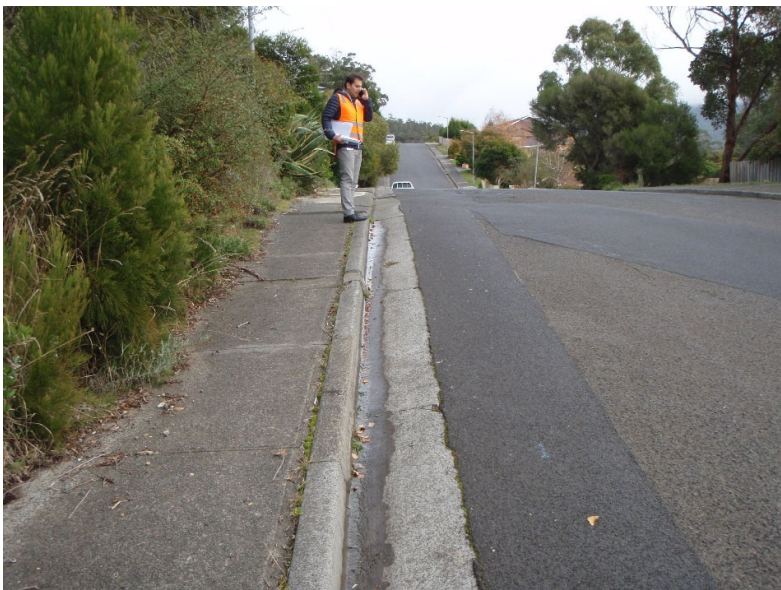
Figure 4 – seepage in the gutter below No 1 Officer Street – see Figure 2 for location.

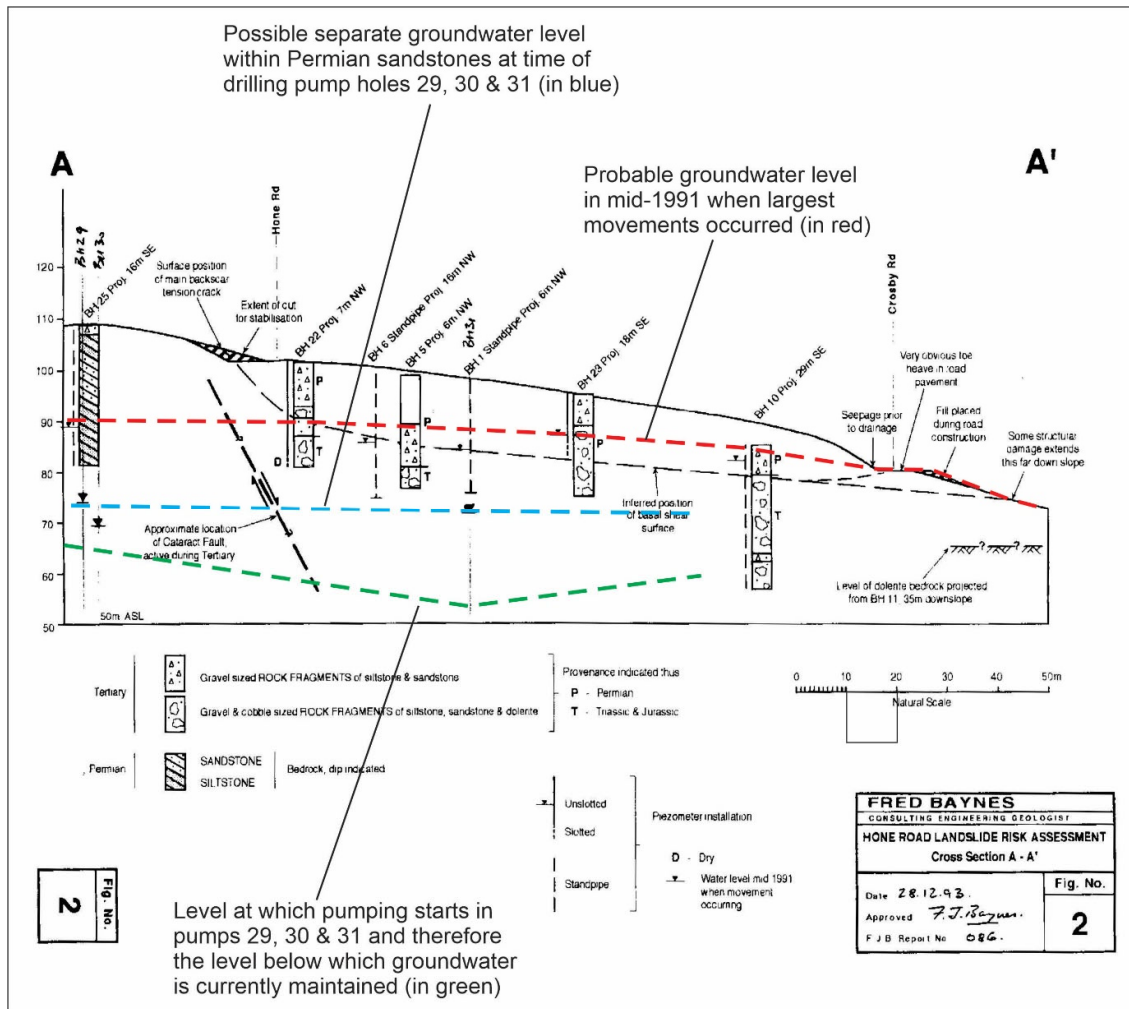
Although there are several boreholes, installed piezometers and around 30 years of records, there is limited detailed understanding regarding the geological and groundwater conditions within the landslide. The following tentative interpretation is suggested:

- There is an upper perched water table within the landslide mass above a less permeable clay rich basal shear plane in the Tertiary sediments
- There is a lower water table within the Permian sandstones and Jurassic dolerites possible connected to the lower parts of the Tertiary sediments
- There is a flow of groundwater from a recharge area to the north-west (in the upper parts of Officer Street) into the landslide area which results in the higher groundwater levels in pump 31.

This suggests that if pumps 29 and 30 were to be switched off a water level rise to around RL 80 is likely and this could reduce the volume of drained ground below the landslide and thus reduce the capacity of the area to safely absorb rainfall events. If pump 31 were to be switched off this would have a similar effect and in addition a water level rise to, say, above RL 86.6 could significantly affect the stability of the landslide. This action is therefore not recommended.

Figure 5 Interpreted groundwater conditions before and after drainage

- 1 Pumps 29, 30 and 31 and their associated top and bottom sensors should be maintained at their present levels and continue to be operated for the foreseeable future, or,
- 2 As for 1 but with the top sensor for pump 31 raised to 30 m below the collar level (i.e. at RL 62.2) so that pump 31 does slightly less work.

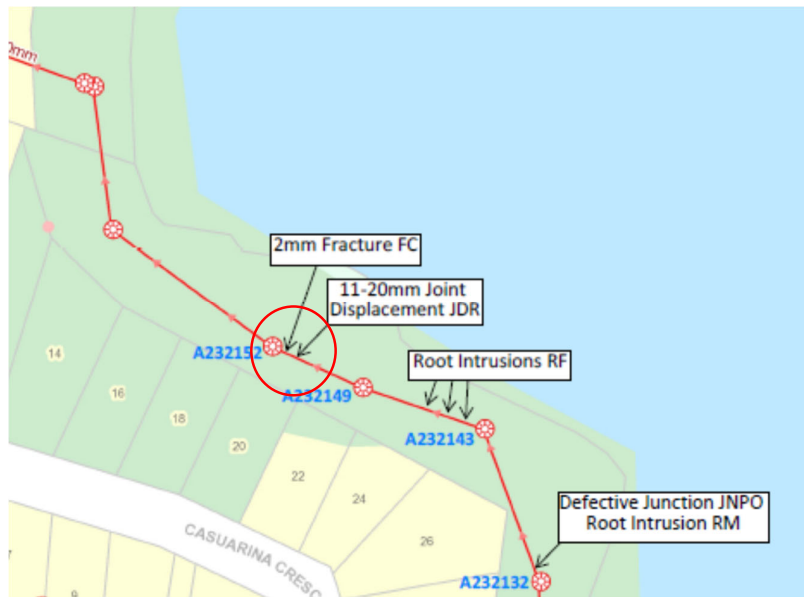
The last survey was in April 2022. There are movements of several millimetres both laterally and vertically, which probably reflect seasonal variations in moisture content of clay soils. There are no significant movements of the landslide apart from Control Point 2 which appears to be showing a displacement of up to 35 mm. When this control point was inspected it was found to be in a relatively active part (the toe) of the landslide adjacent to a sewer main (location indicated in Figure 6). Review of recent crack monitoring of the main indicated that cracks up to 20 mm were observed in the sewer during a recent camera inspection (Taswater Infrastructure Displacement map for Casuarina Crescent 26/5/2021). It appears that leakage from the sewer and landslide movements may be interrelated, with movement causing cracking and leakage accentuating movement.

Figure 6 – location of Point 2 close to cracked mains sewer, circled in red

It is recommended that the matter be drawn to attention of Taswater and that the leaks should be repaired, as further leakage has the potential to reactivate the landslide and possibly cause property damage and environmental impacts due to the release of sewage onto the foreshore.
