My Ref: BG-296-220117-Rpt27-DRAFT

Glenorchy City Council

REVIEW OF LANDSLIDES FOR GCC
REPORT 27 – 17 January 2023

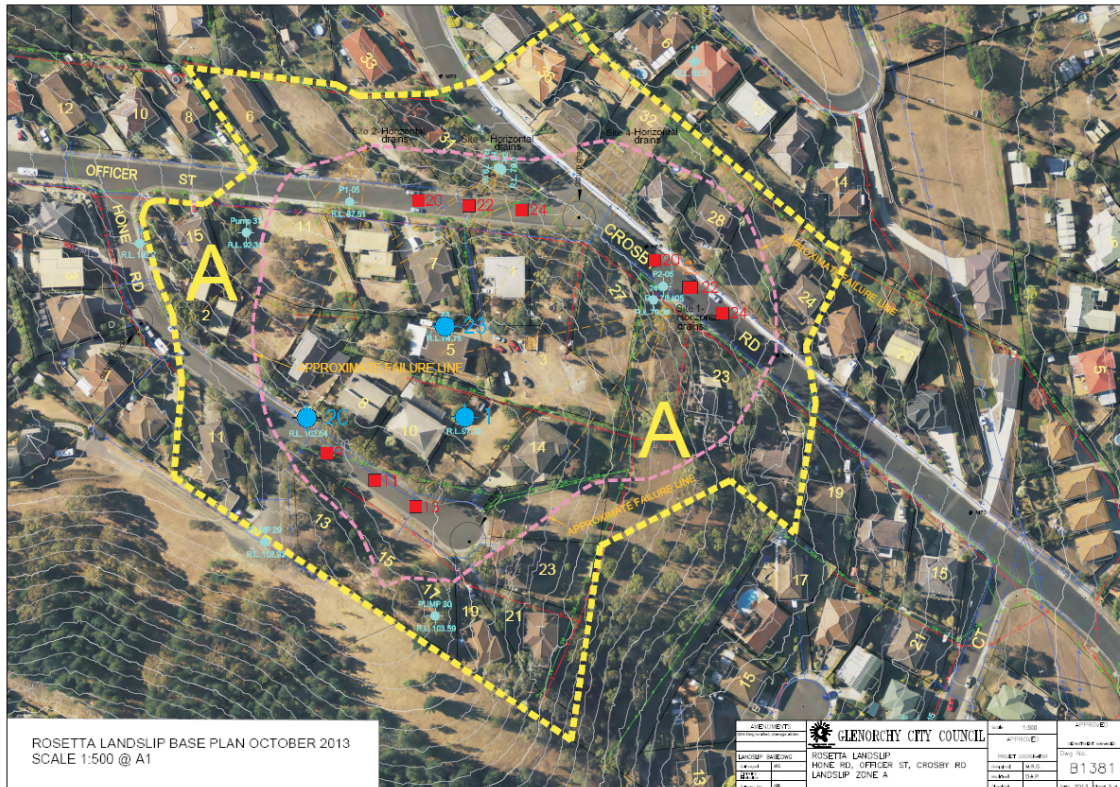
The most useful monitoring data to understand the behavior of the landslide is provided by nine monitoring points and the water levels in three piezometers installed in boreholes and three boreholes in which pumps have been installed, the locations of these are shown on Figure 1.

Figure 1 Critical survey monitoring points (in red) and groundwater monitoring boreholes (in blue).
