19 October 2023

My Ref: BG-296-221019-Rpt29-DRAFT

REVIEW OF LANDSLIDES FOR GCC  
REPORT 29 – 19 October 2023

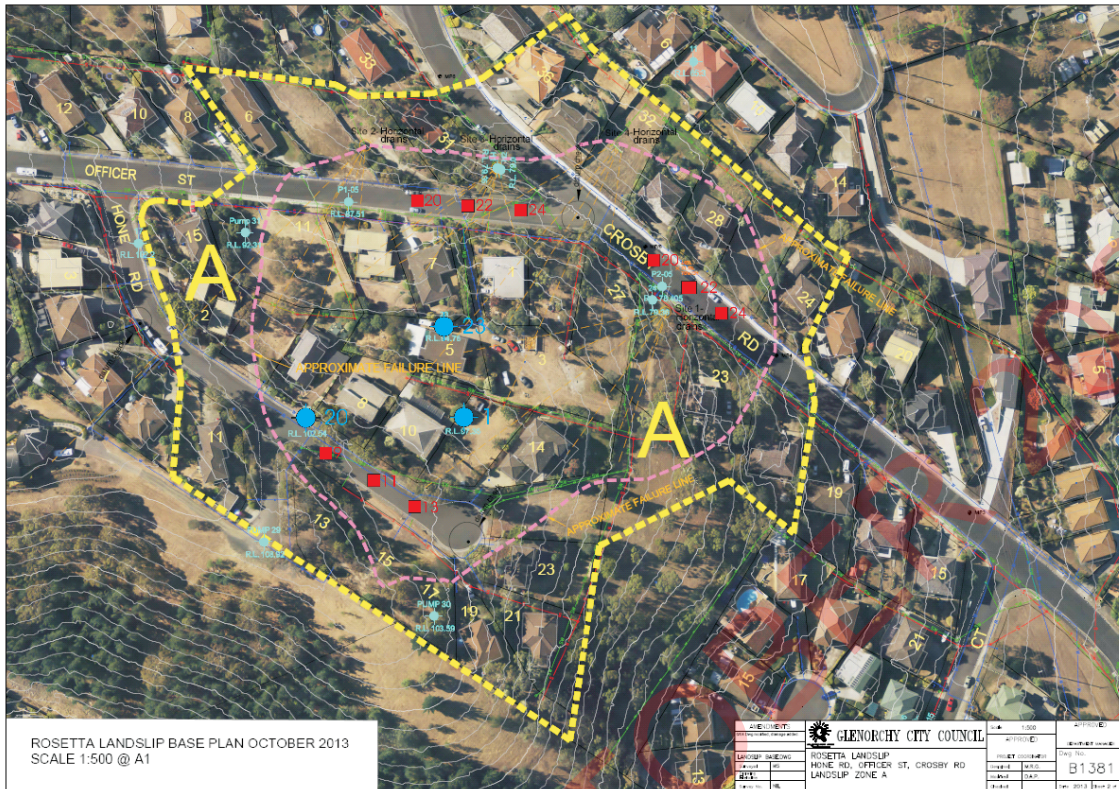
The most useful monitoring data to understand the behavior of the landslide is provided by nine monitoring points and the water levels in three piezometers installed in boreholes and three boreholes in which pumps have been installed, the locations of these are shown on Figure 1.

Figure 1 Critical survey monitoring points (in red) and groundwater monitoring boreholes (in blue).
