BRIDGEWATER CROSSING: GRANTON INTERCHANGE Historic Heritage Assessment

Final Report prepared for
GHD Pty Ltd

2 June 2011

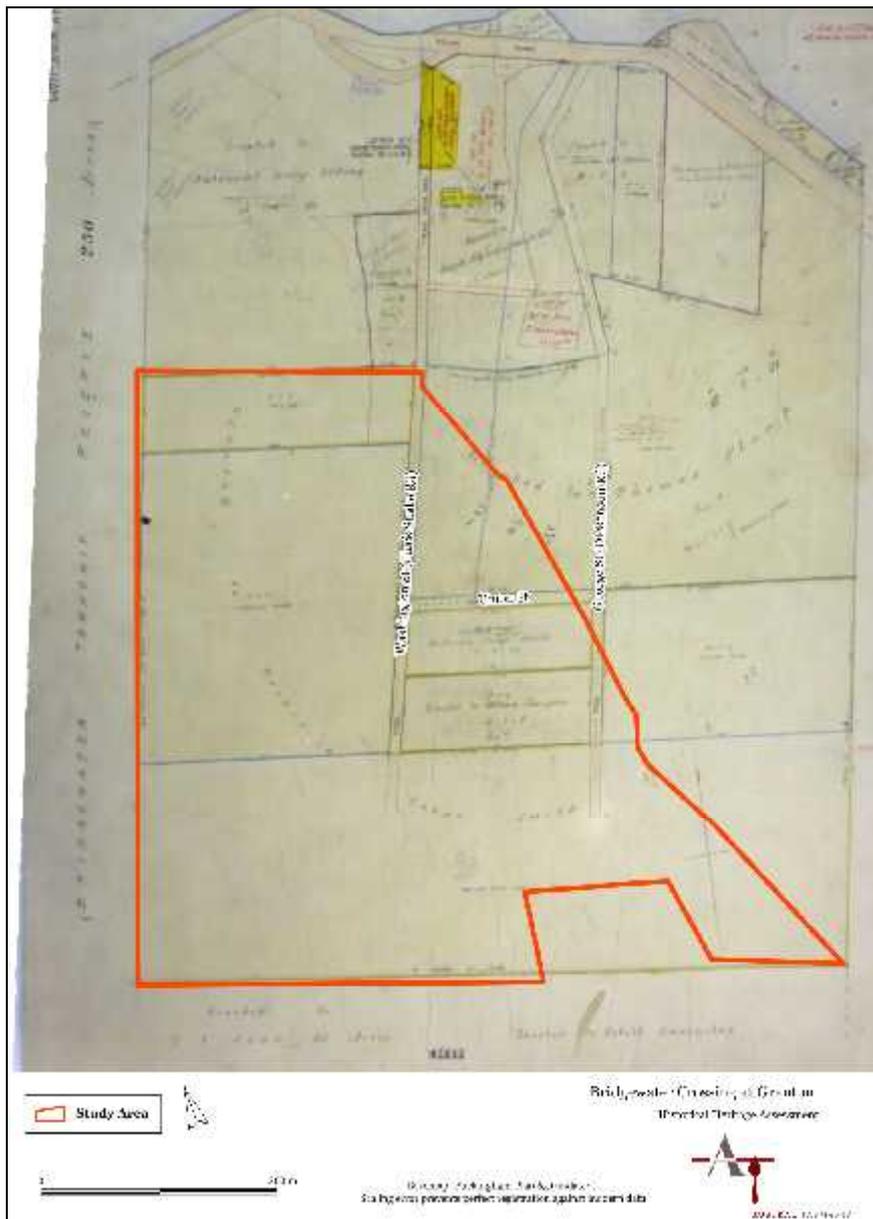
Figure 4. Buckingham Plan 65 (undated) (© State of Tasmania, reproduced with permission)

Plan 65, Buckingham (undated), which deals in finer detail with the land surrounding the study area, introduces the names Joseph Allport and James Gill, Duncan McPherson and Henry Morris as grantees to parcels in the location. This plan also indicates the existence of the Main Road from Hobart Town to New Norfolk, hugging the southern bank of the River Derwent; an area of reserve for the township of Bridgewater (which was never built here, but across the river on the northern bank); and three streets called Washington (later Black Snake Road), Union (no longer in existence) and George (later Dickenson Road). See Figure 4.

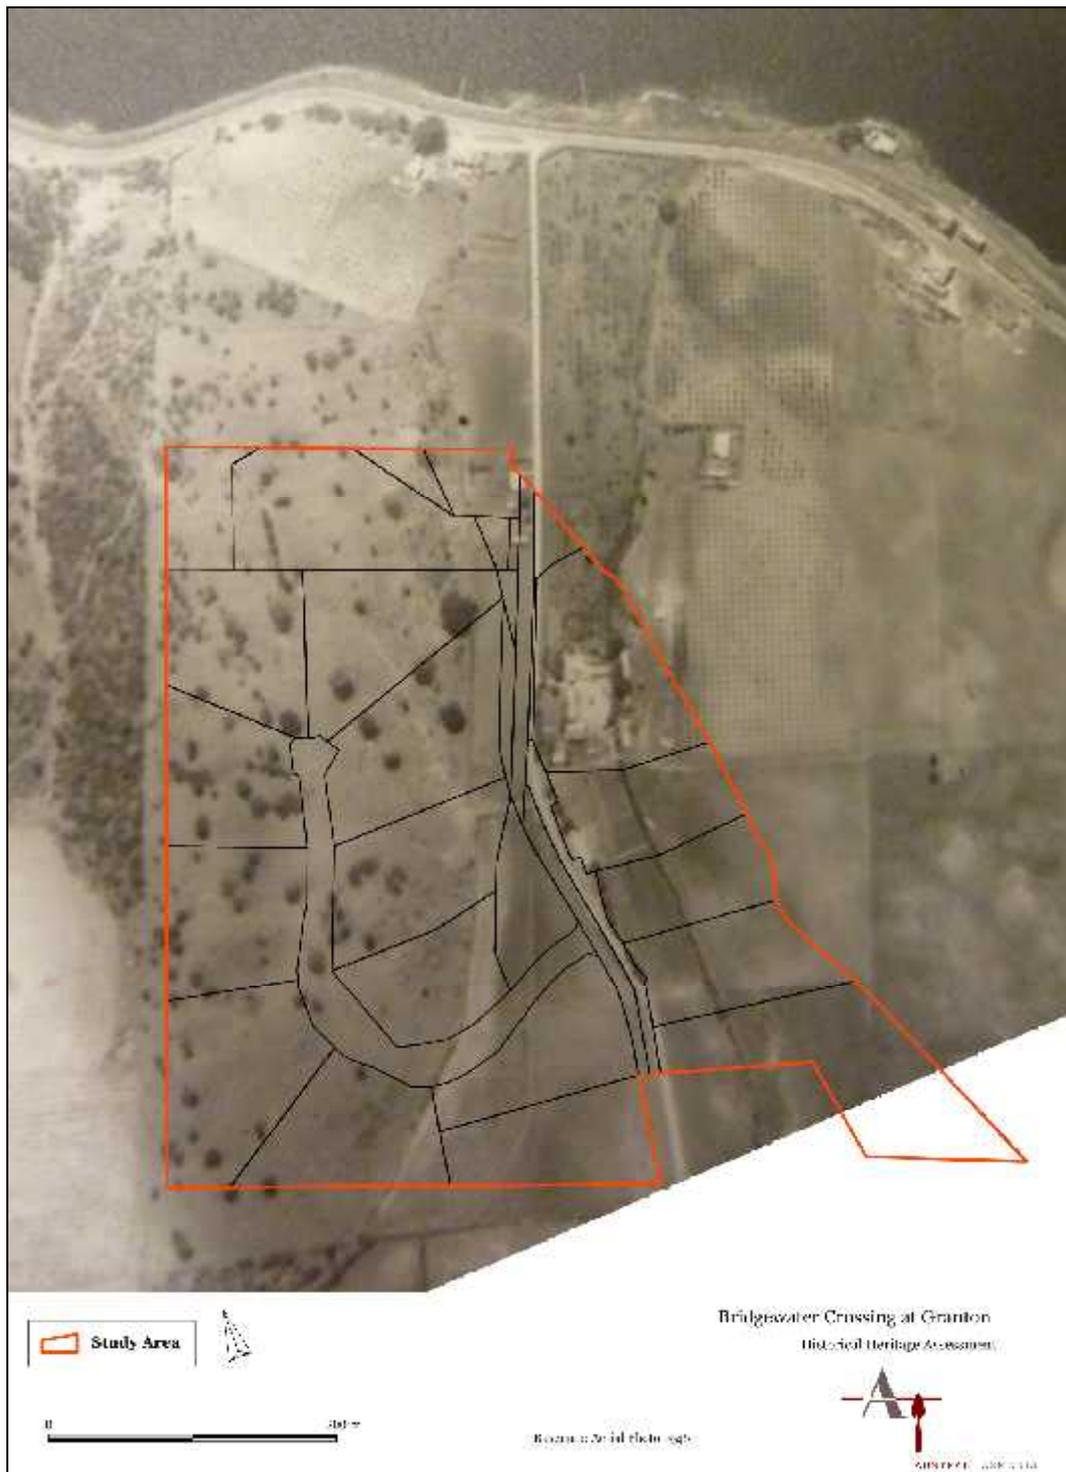
Figure 5. Aerial photograph from 1946 (Tasmanian Archives and Heritage Office, LSD 353/1/3, Hobart, Run 1, 1946, Photo 19748, 1946, reproduced with permission)

Significantly, the air photo shows only two groups of structures within the study area - three small buildings at the north east corner on the western side of Black Snake Road, and a cluster of structures some 150 m south, on the other side of the road (see Figure 5). It is likely this cluster represents some of the buildings visible in current aerial imagery.

History: No specific historical context was established for these trees. They are, however, clearly visible on an aerial photograph dated 1946 (refer to Figure 5). In that photograph, by comparison, the northern-most pair appears to be large and therefore, potentially of a greater age than its southern-most counterpart (although environmental factors may also explain the differential growth rates). The latter grouping appears associated with plantings lining either side of an internal access track (no longer discernible in the present) that appears to trend in a north-easterly direction to the top of the ridge.

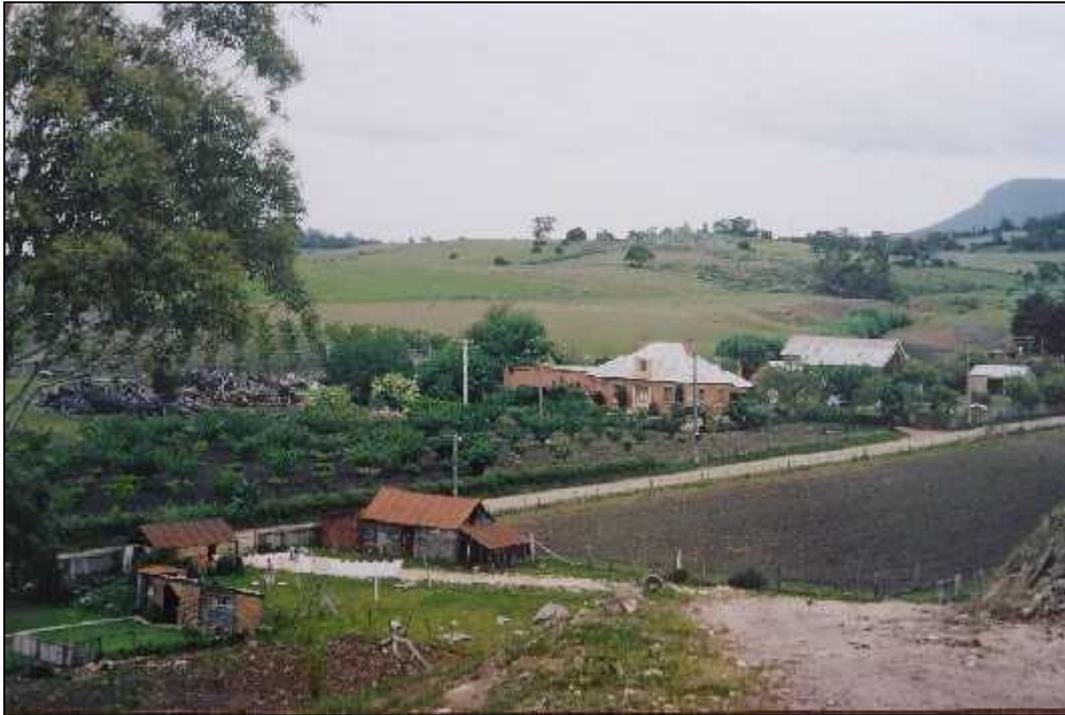
Figure 6. Mid-twentieth photograph of homestead prior to 1955 renovations, looking to the south east. Note the number of outbuildings and surrounding orchard (photograph provided by L Dickenson and included with permission)

It was during King’s ownership that a house was constructed on the property. This building was initially a single storey brick building of pit-sawn framing on sandstone foundations, with a skillion kitchen to the rear (see Figures 6-9).³⁰

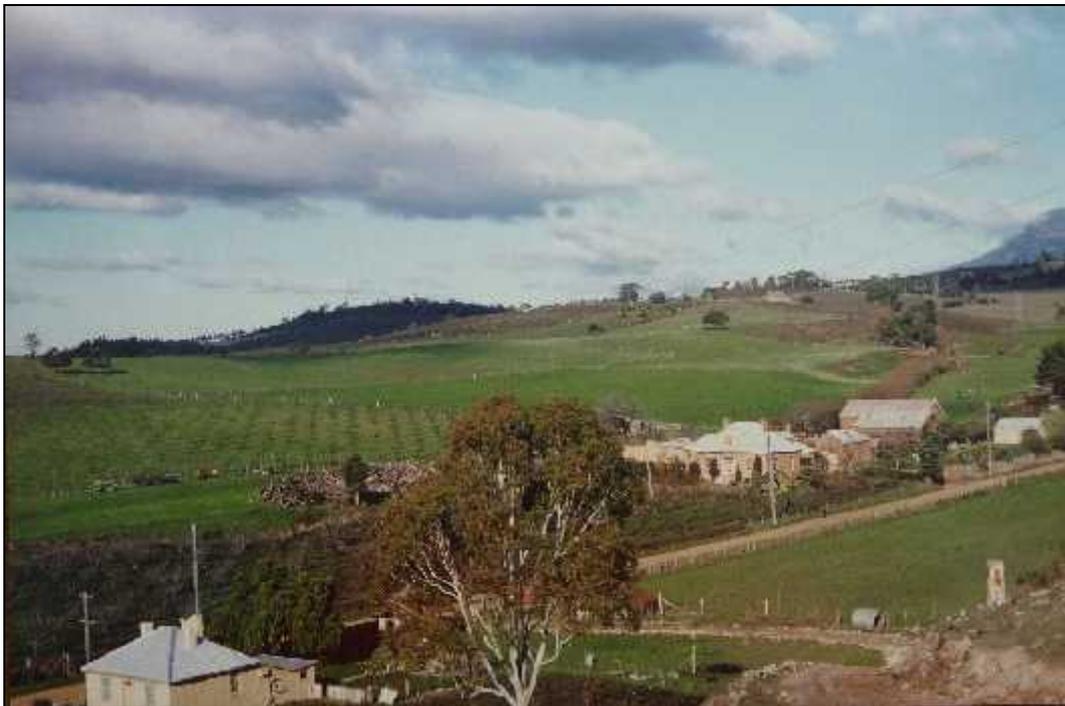
Figure 7. Mid-twentieth photograph of homestead prior to 1955 renovations, looking to the south east. The house at the bottom left of picture was destroyed during construction of the Brooker Highway interchange (photograph provided by L Dickenson and included with permission)

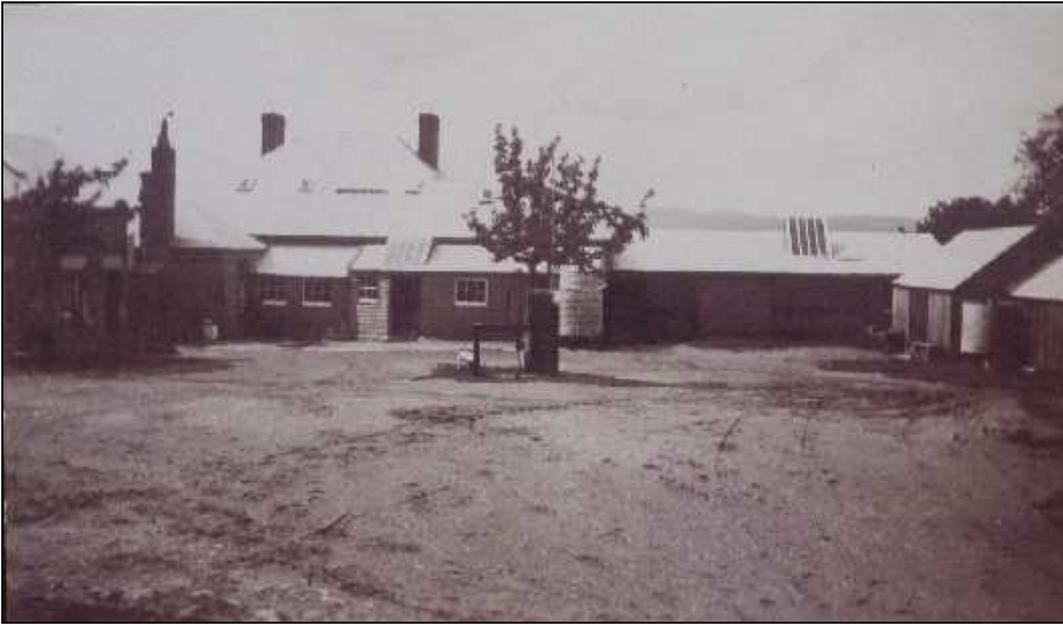
Figure 8. Early photograph of the rear of the homestead showing skillion kitchen area, the coach house and other outbuildings (photograph provided by L Dickenson and included with permission)

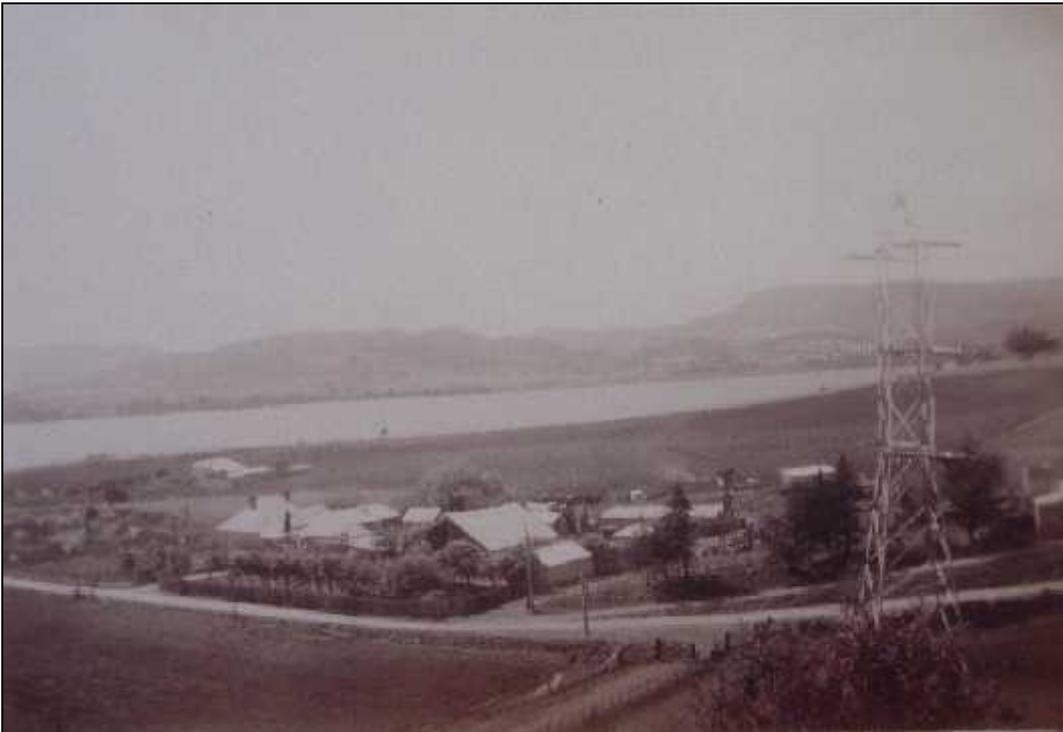
Figure 9. Early photograph of the homestead complex, looking to the north east (photograph provided by L Dickenson and included with permission)

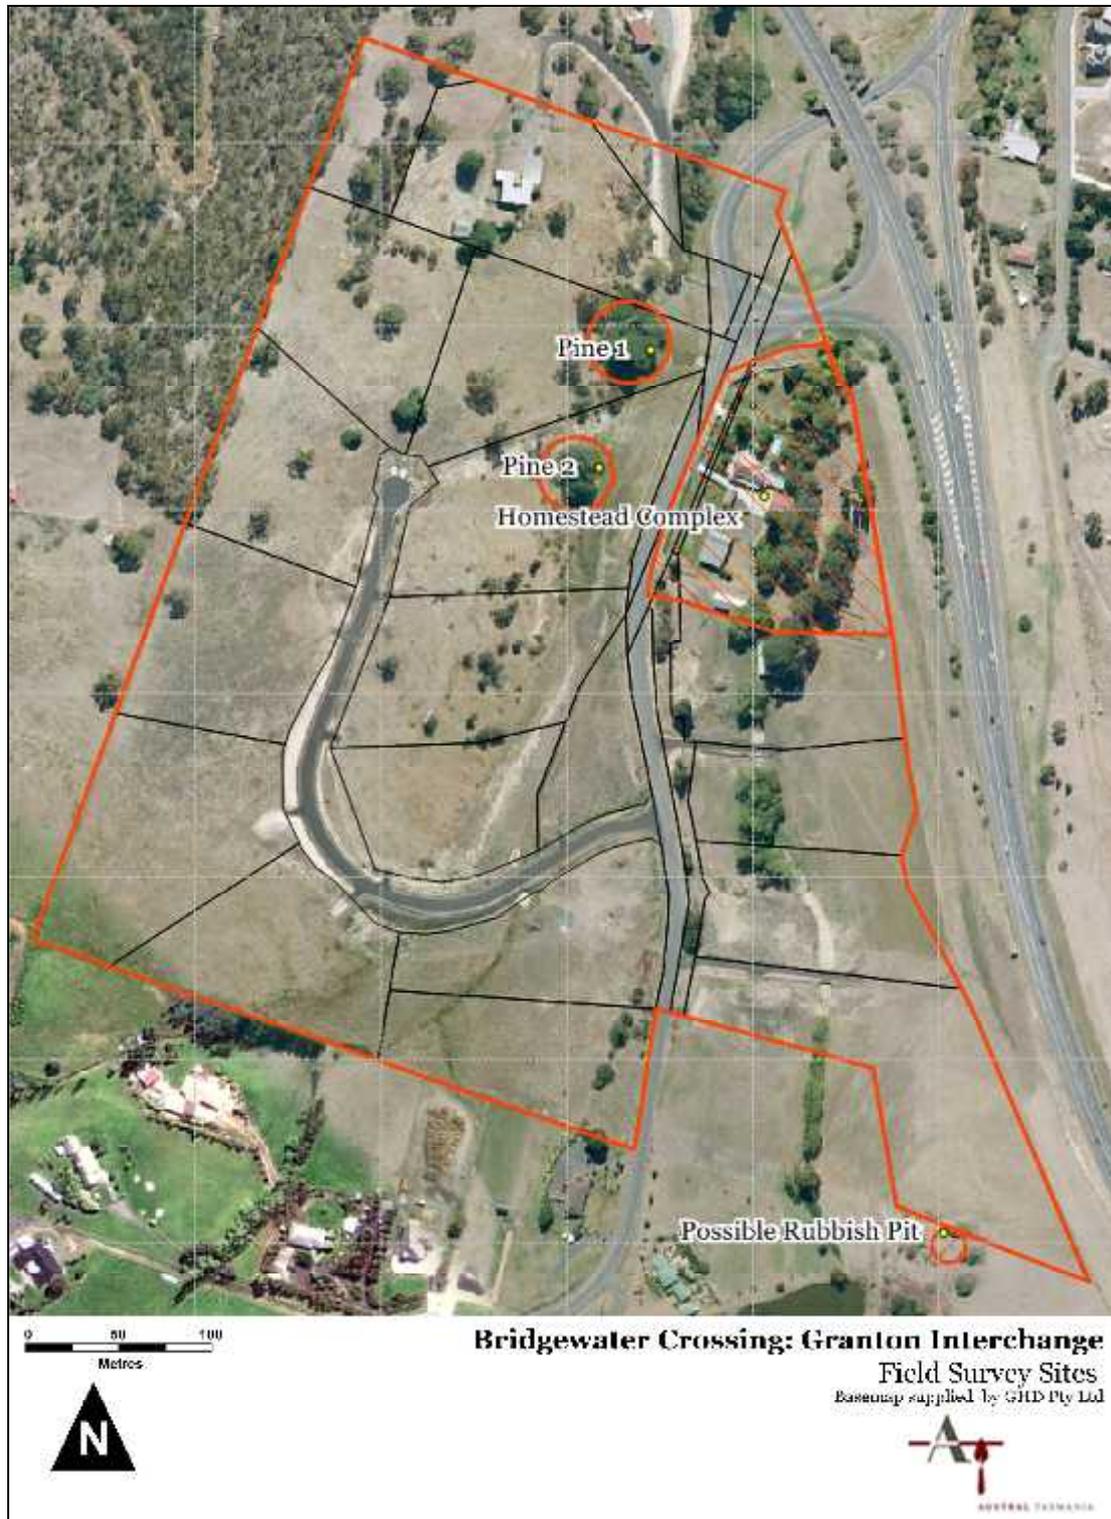
Figure 11: Map showing the entire study area

The following overlay (Figure 11) shows the places, sites and features identified during the assessment. Further details are provided in three data sheets in section 4.4.

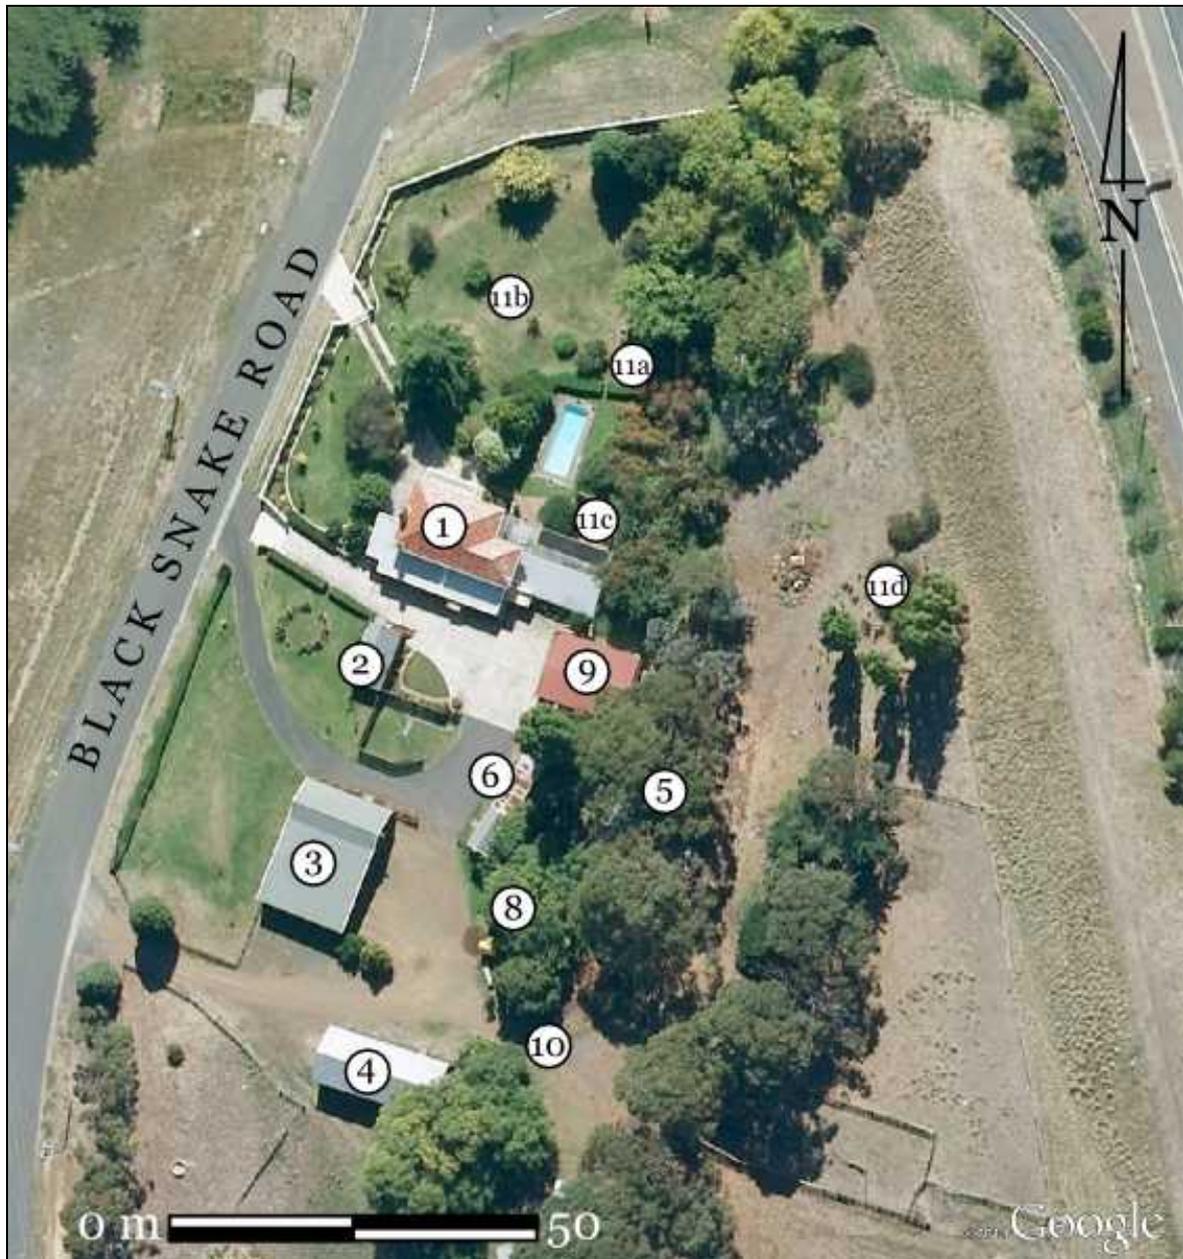
Figure 12: Map showing the site complex at Black Snake Road (see Inventory Sheet 1 for further details)

The following annotated map (Figure 12) shows the key elements and features comprising the property at 37 Black Snake Road.

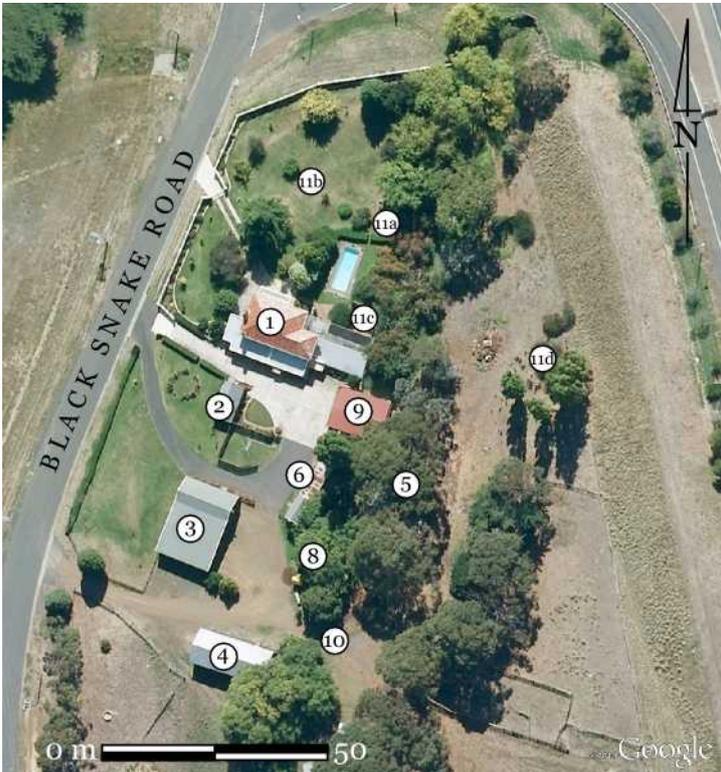
<p>Illustration 2: Front of Main House showing balcony and columns added in 1955.</p>

1/1: In the event that impacts to the site complex arising from design and construction of the proposed new Bridgewater crossing are found to be unavoidable, carry out the following to mitigate impacts to the identified historic heritage values:

- (a) Prepare an illustrated archival record of the key attributes of the complex. The record should contain detailed descriptions and annotated photographs of the key buildings named in this data sheet; an inventory of moveable heritage items including the contents of the Blacksmith's shop; a detailed recording and measured drawing of the sandstone culvert, and; a full description of the setting and, production of an annotated overlay showing key plantings. The information gathering phase should be completed prior to any salvage of items (as recommended in (c), below).

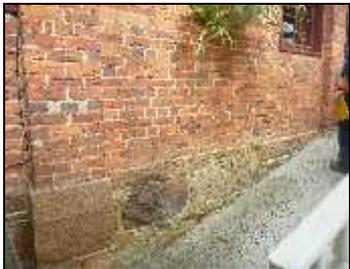
<p>Illustration 3: Detail of wing of house showing hand pressed clay bricks and sandstone construction.</p>	<p>Illustration 1: Map showing location of buildings within the property.</p>

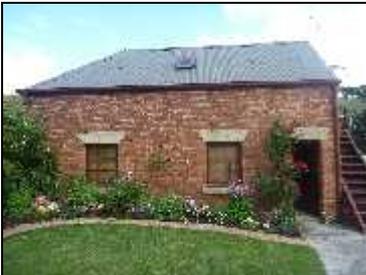
<p>Illustration 4: External view of the cottage from the east.</p>

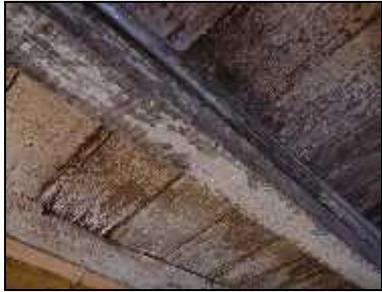
<p>Illustration 5: Detail of interior ground floor. Timbers are pit-sawn.</p>

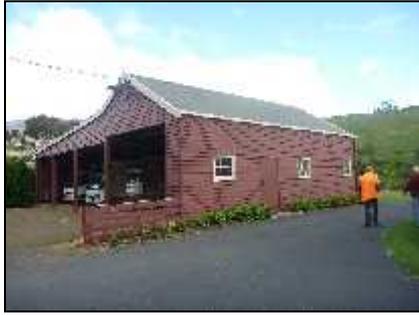
Illustration 6: Exterior view of the stable.

The stable (3) is a large shed with four vehicle bays in the open north wall of the building. Erected by John Dickenson c.1898, it is constructed of weatherboard over timber framing with a broken-backed pitched and gabled roof. The north wall hosts three timber-framed lighted windows and a single hinged door constructed of vertical timber boards. Cast-iron hinges on the door have been recently installed by the current owner. The lack of interior cladding reveals the framing and weatherboard construction (Illustration 7). One interior timber wall remains from its use as a stables and this holds sliding hatches used during the feeding of the horses.

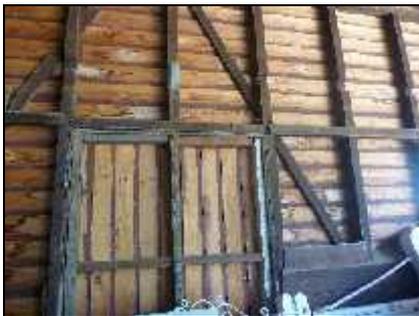
Illustration 7: Interior of north wall showing framing and weatherboard construction.

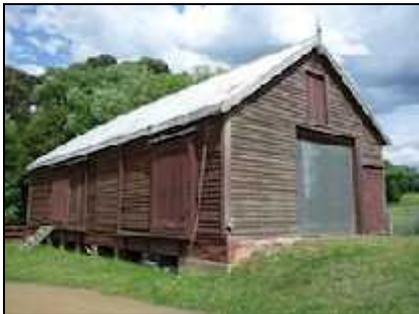
Illustration 8: Former rail shed relocated to its present site from the Granton Railway Station.

Railway shed (4). A timber framed weatherboard shed with a gable roof lies at the southern end of the complex (Illustration 8). This was originally a railway shed sited at the Granton Railway Station and brought onto the property sometime in the 1950s by Mr Lyndon Dickenson's father. Large barn-style doors open on the west wall and the north wall supports three heavy sliding doors. The northern edge of the shed stands on a concrete foundation approximately 1.2 m high. A finial comprises a decorative detail at

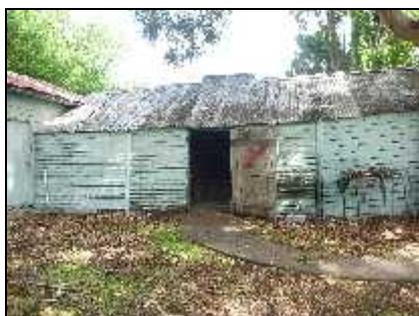
Illustration 9: Exterior (east wall) of the smith's shop.

The Blacksmith’s shop demonstrates the ongoing use of the property as a working farm from an early age, and suggests continuity in this activity until near the present time. The replacement of the bellows demonstrates technological adaptation. The hinges on the cupboard door demonstrate a vernacular tradition of finding simple, cost effective yet innovative solutions to day-to-day problems.

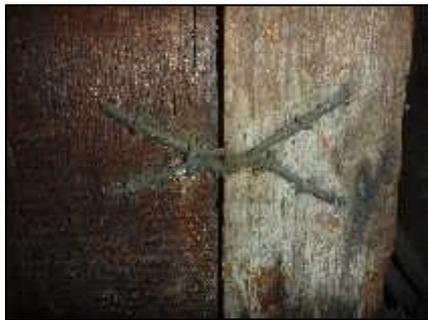
Illustration 10: Hand-made hinges on cupboard doors, smith's shop.

Inside the smith's shop, the forge stands next to a rack containing a collection of hand-made tongs and pincers. The bellows have been replaced with an electric-powered fan. Boxes of materials and tools surround the interior walls, including a hand-powered mechanical drill press mounted to the west wall, and a large cast-iron vice on a bench attached to the north wall. The doors of a wooden cupboard on the west wall are hinged with two tidy creations of fencing wire and staples (Illustration 10).

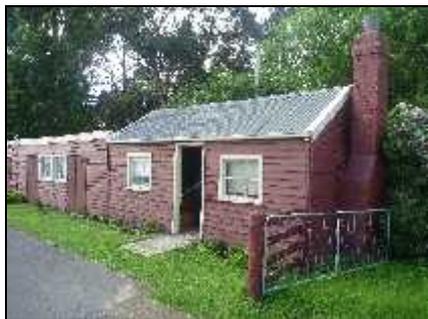
Illustration 11: Workers hut showing relationship to sheds.

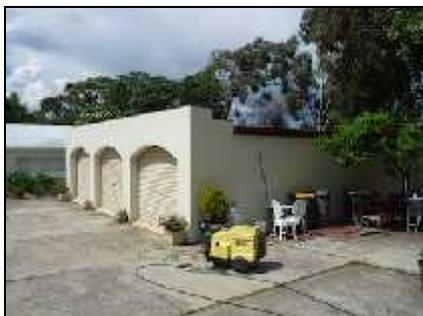
Illustration 13: Former coach house (extensively modified)

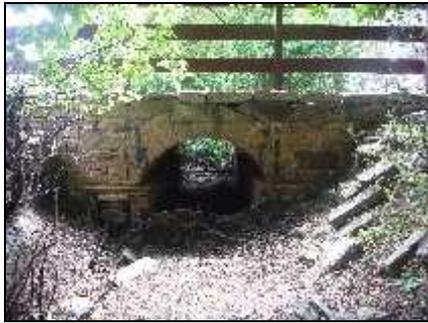
Sandstone culvert (10). A sandstone arch comprising a keystone and five voussoirs on either side is founded on sandstone blocks with filling abutments constructed of coursed sandstone blocks (Illustration 14). The interior barrel of the arch appears partly rendered. The structure is surfaced with gravel. Timber railings have been added.

Illustration 14: Upstream side of stone bridge/culvert

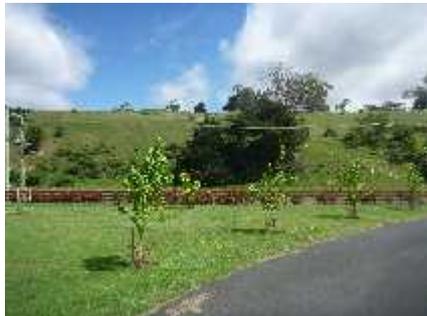
Illustration 2: Southern pair of conifers (viewed from 37 Black Snake Road).

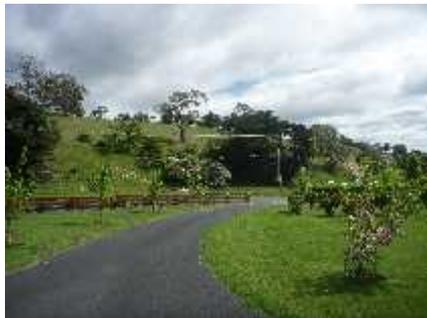
Illustration 3: Northern pair of conifers (viewed from 37 Black Snake Road).

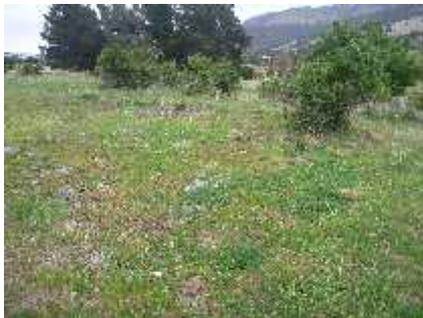
Illustration 2: Possible rubbish dump outside south-eastern boundary of the study area

History: This was reported by Lyndon Dickenson as a possible former dump site.

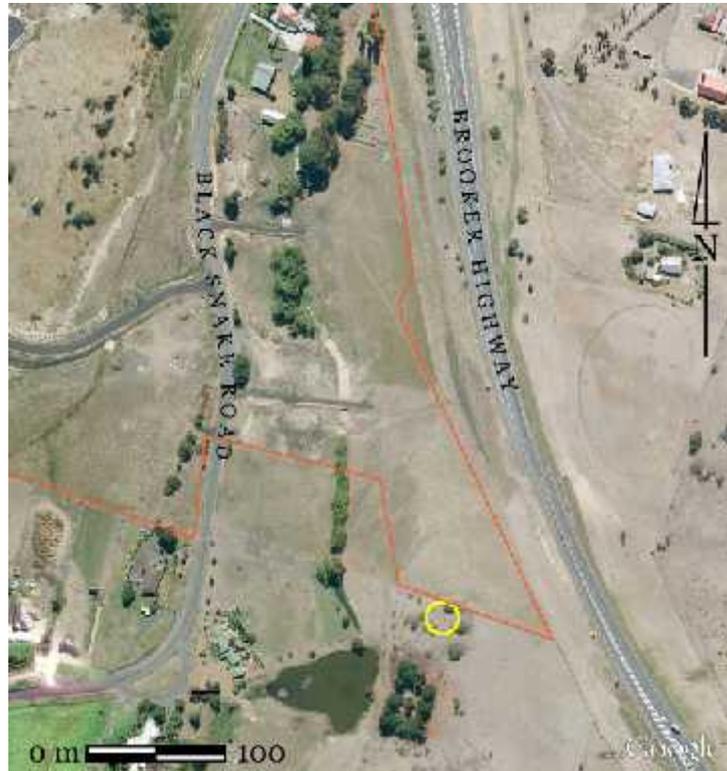
Illustration 1: Map showing location of possible rubbish pit just beyond the study area (red line).
