Re: Proposed new single dwelling at 63 Bimburra Road, Glenorchy

BUSHFIRE HAZARD REPORT

FLOOD PRONE AREAS HAZARD ASSESSMENT

GEOTECHNICAL SITE INVESTIGATION AND LANDSLIDE RISK ASSESSMENT

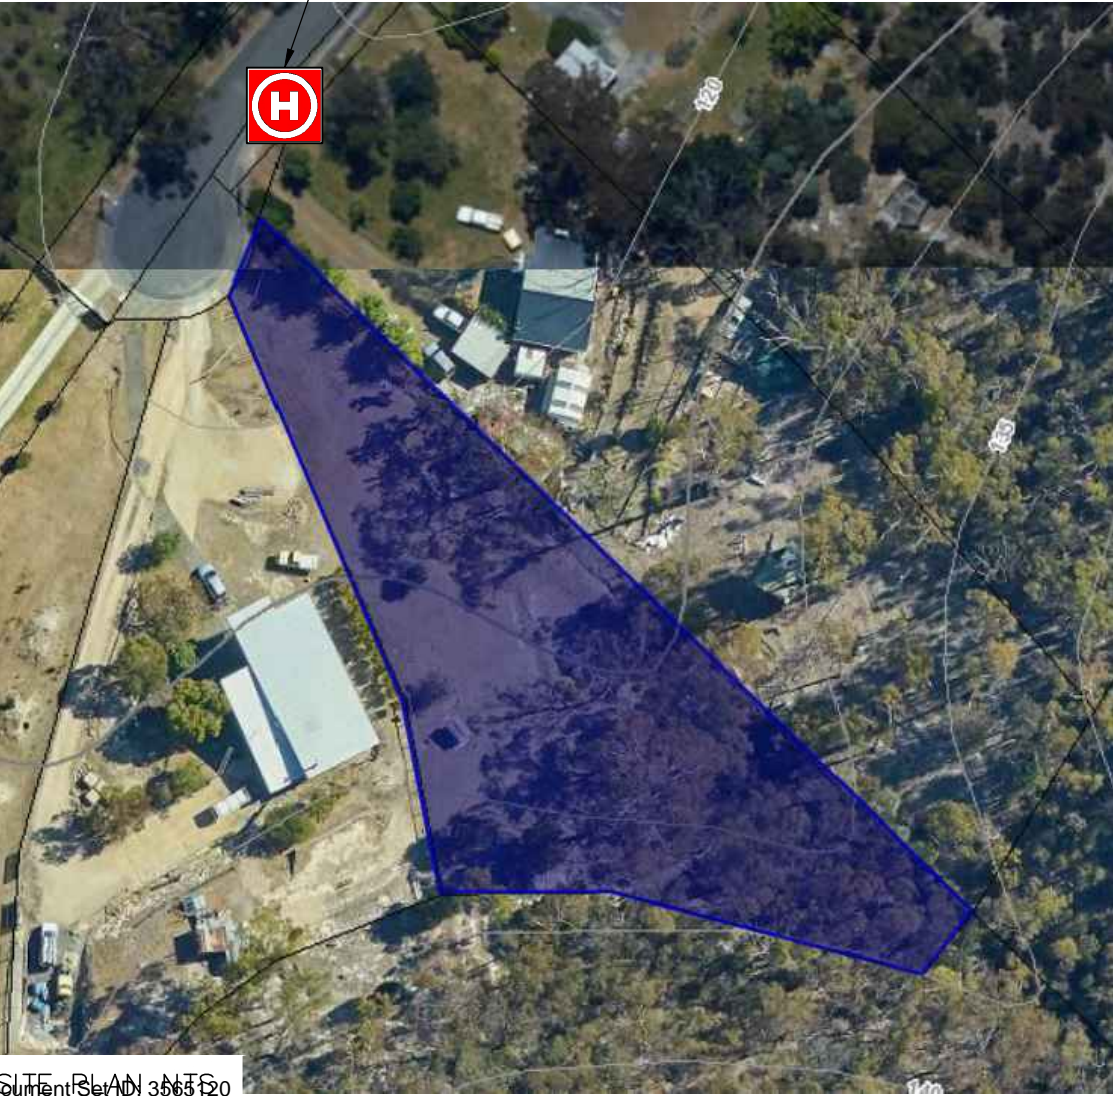
HAZARD MANAGEMENT AREAS – HMA
Hazard Management Area includes the area to protect the Building as well as the access and water supplies. The entirety of this allotment should be treated as HMA. Vegetation in the Hazard Management area is to be managed and maintained in a minimum fuel condition.
The HMA is determined from the unmanaged vegetation on neighbouring allotments, and should the level of the unmanaged vegetation increase the BHMP and HMA should be reviewed to determine the ongoing suitability of the BHMP and HMA associated with the development.

HAZARD MANAGMENT AREA
Low threat, maintained vegetation in accordance with AS 3959 – Clause 2.2.3.2 (e) & (f). Building is to be constructed to meet BAL–29 requirements

existing hydrant within 120m hoselay

PROPOSED DWELLING

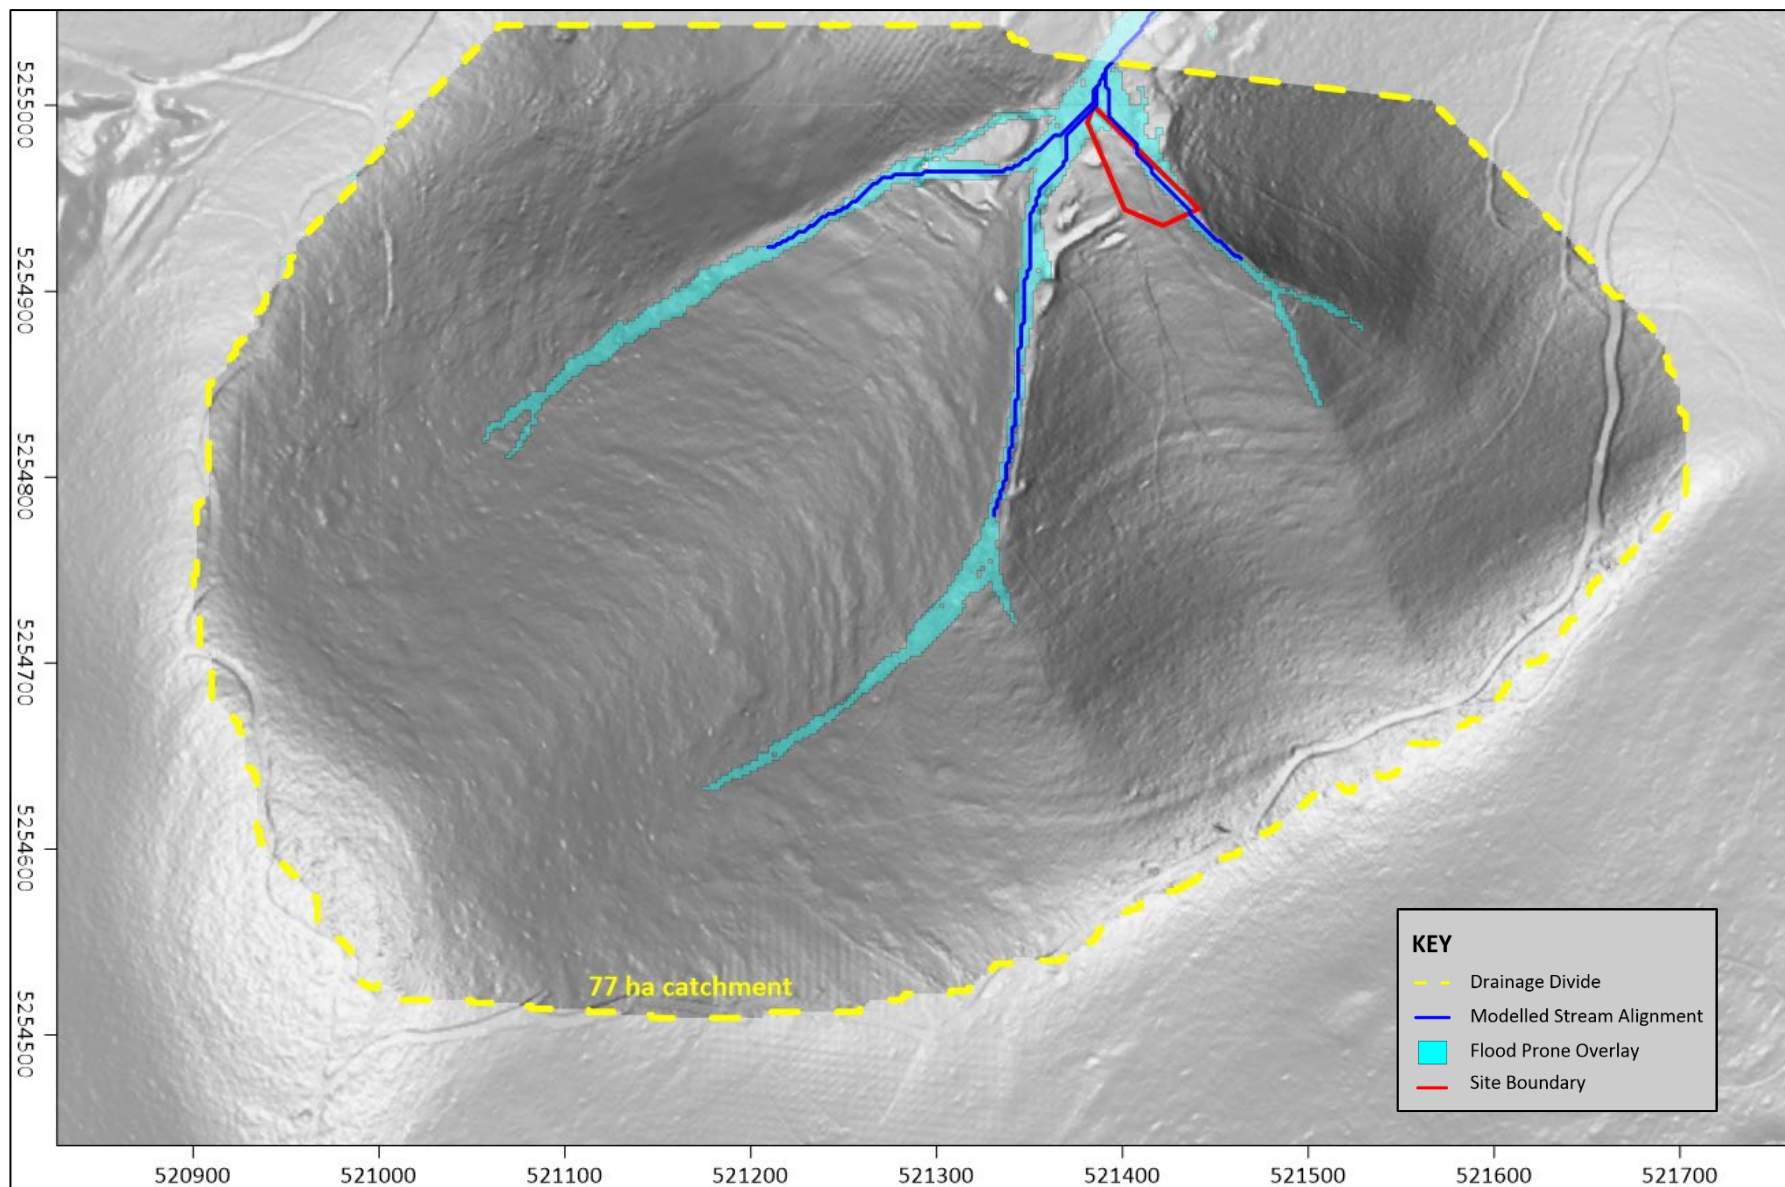
Map 1 Site regional Hillshade setting with Local Surfer Watershed Model

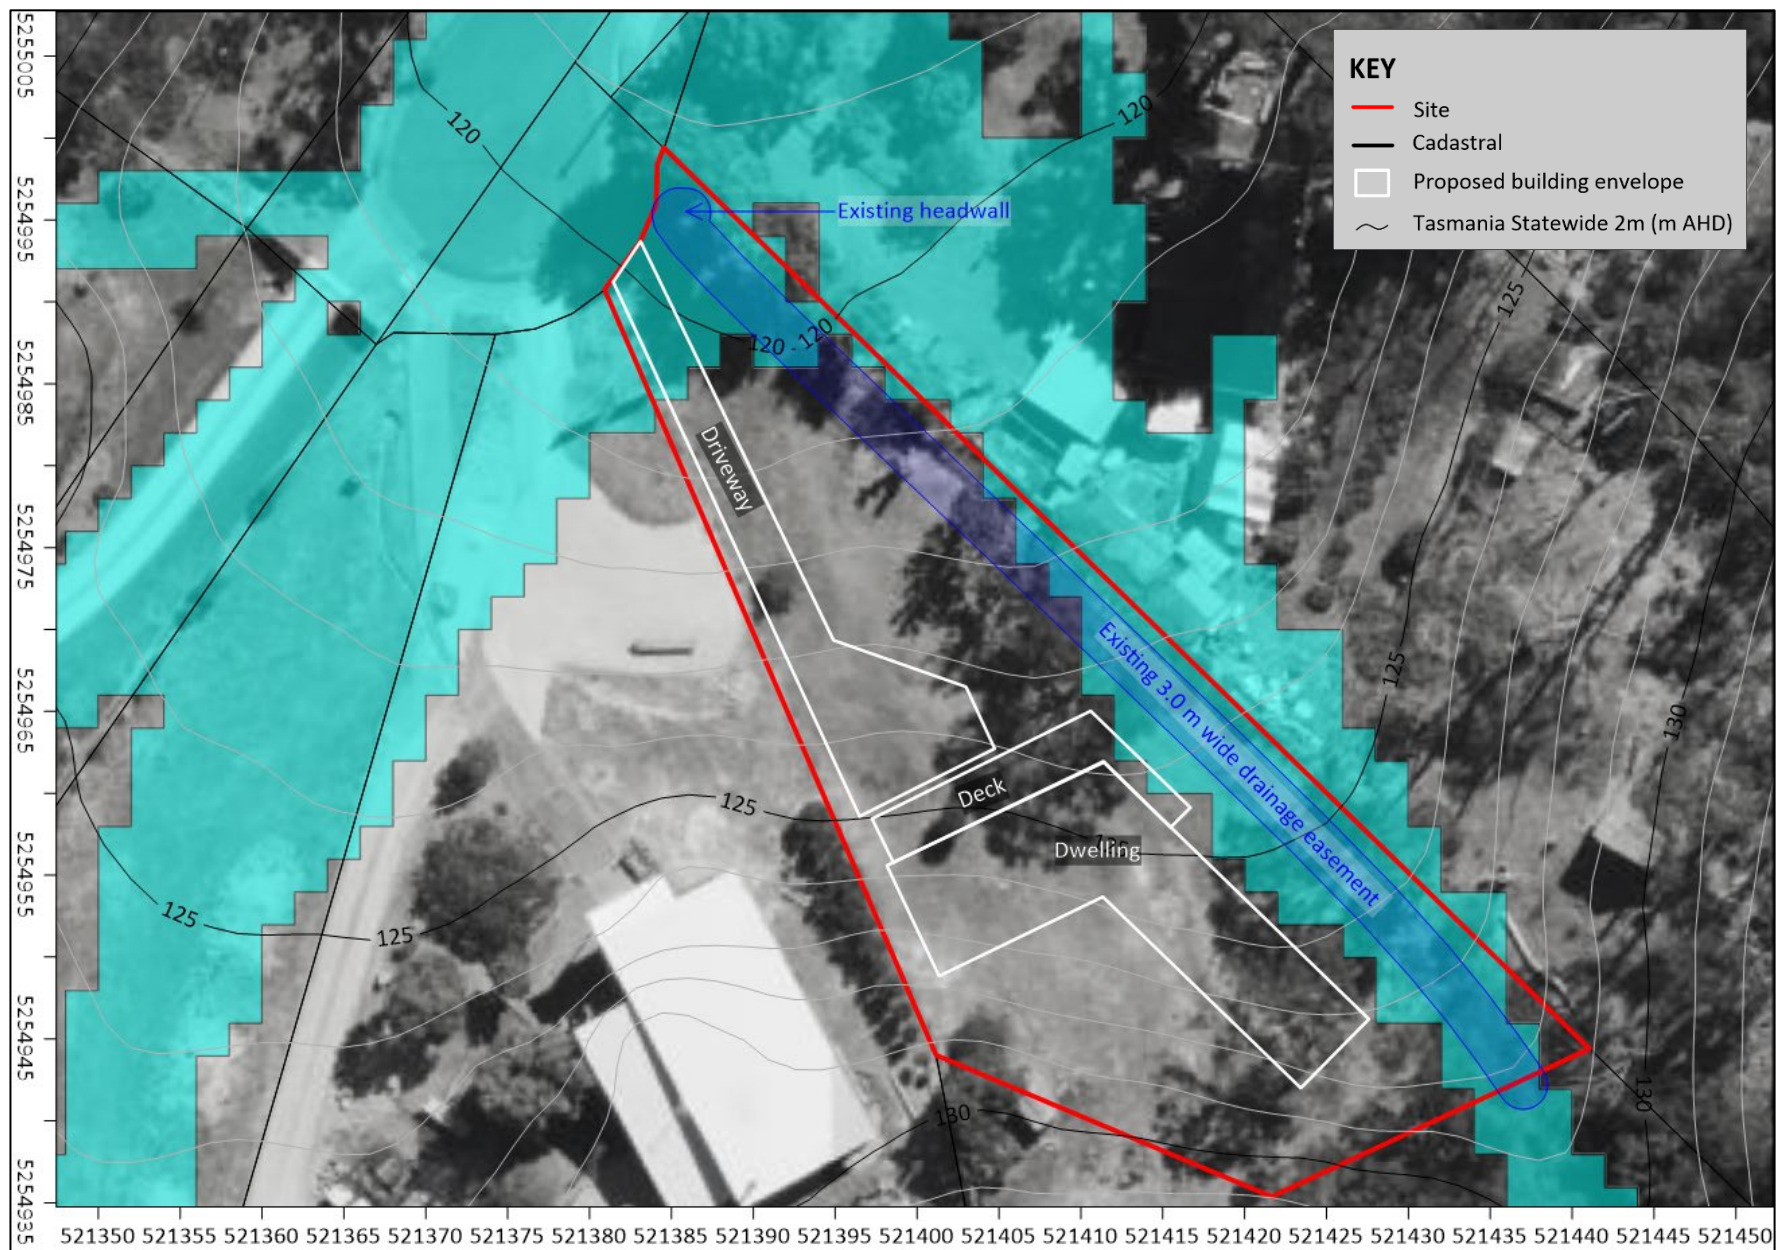
Map 2 1% AEP Floodwater hazard overlay prepared by the local government authority and cross section

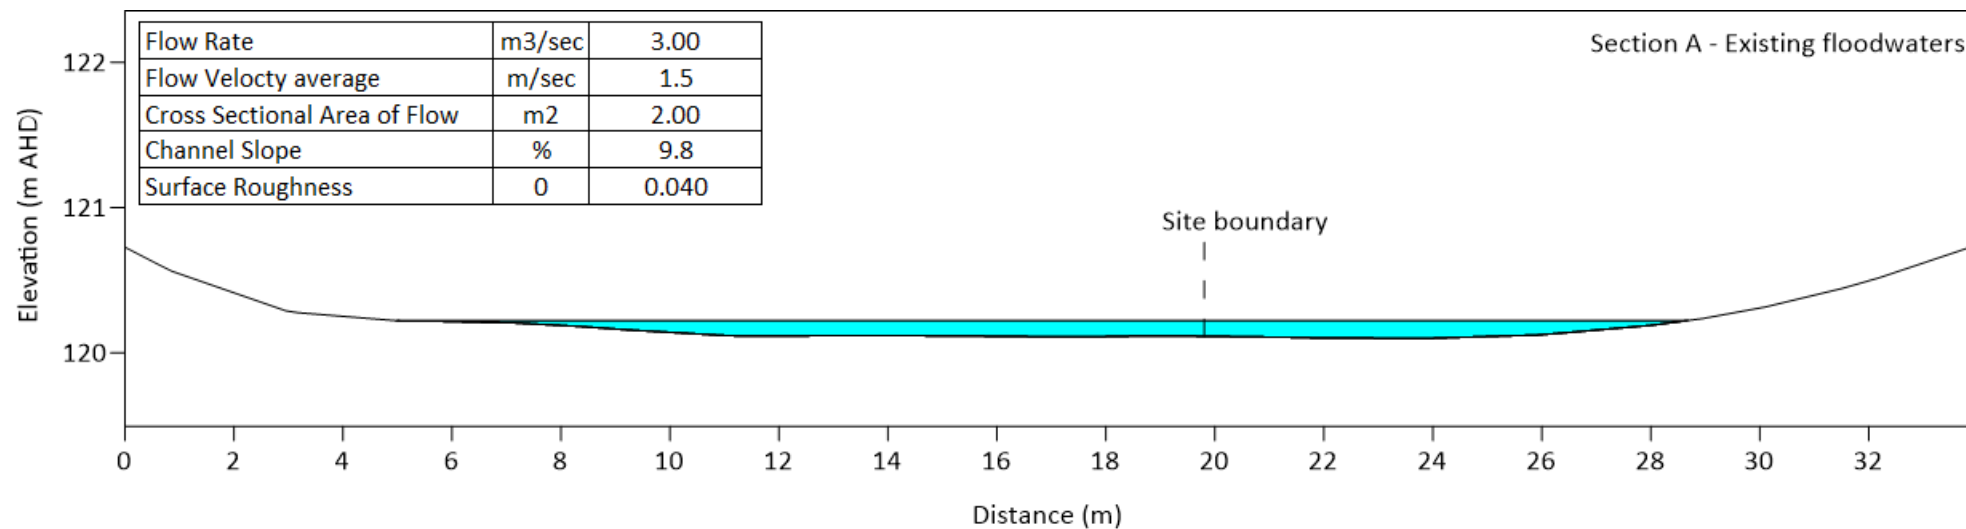
Figure 1 AEP Site Stormwater Flow Analysis – Cross Section A Within the proposed driveway footprint – Drawing Is to Scale and For Conceptual Modelling Purposes Only

- A large upstream catchment (~77 ha) contributes overland flow toward the Site from the south and southwest.
- A cross-section modelled flow of 3.0 m³/s at the driveway, with a channel slope of 9.8% and average flow velocity of 1.5 m/s (Figure 1).

This cross-sectional analysis (see Figure 1, Section A – Existing Floodwaters) confirmed a shallow, broad flow path traversing the Site at the driveway entrance. Flow depths were found to be generally less than 200 mm, with no obstructions or modifications to natural flow at this location under current conditions.

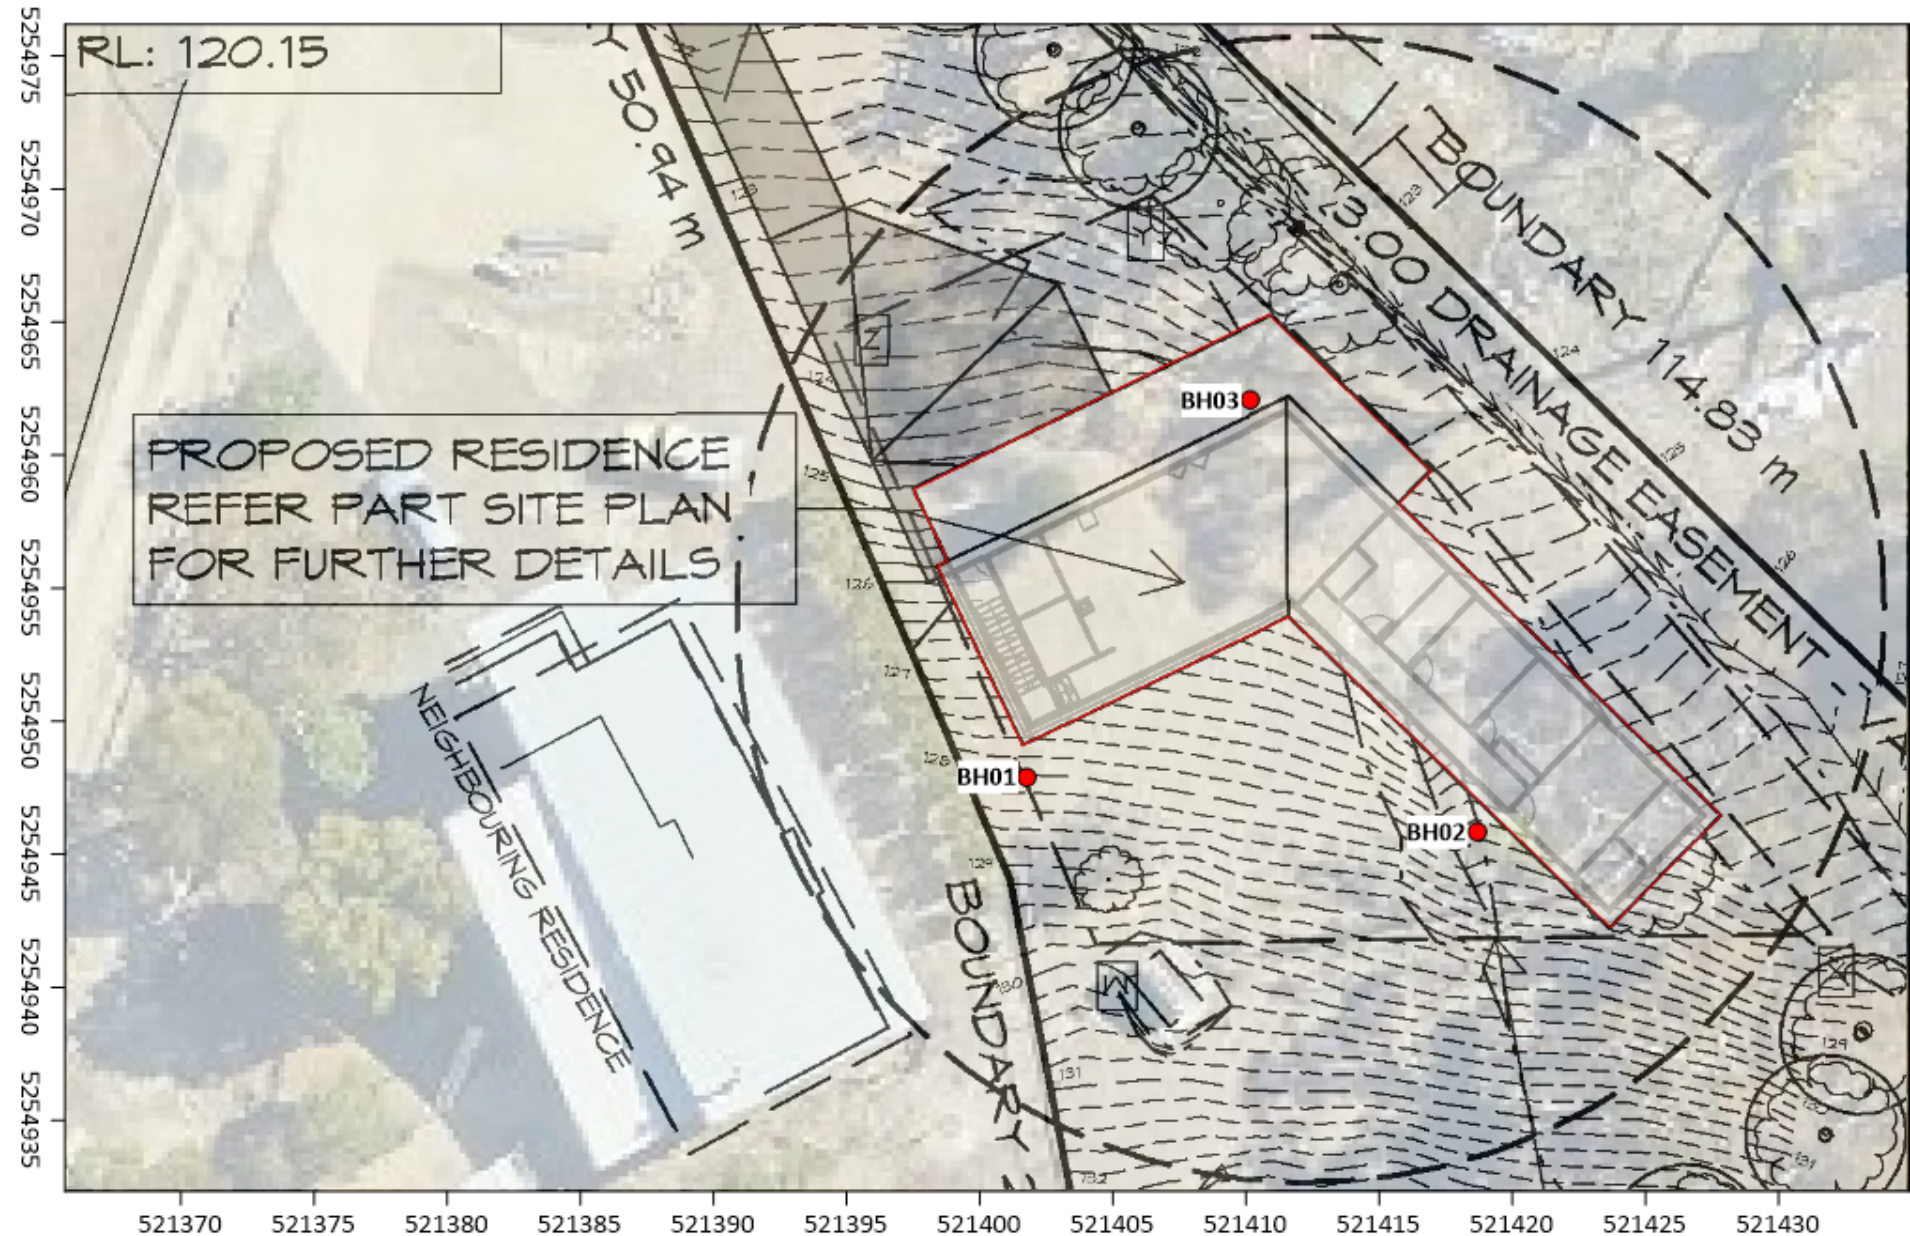
Figure 1 Site Borehole Locations

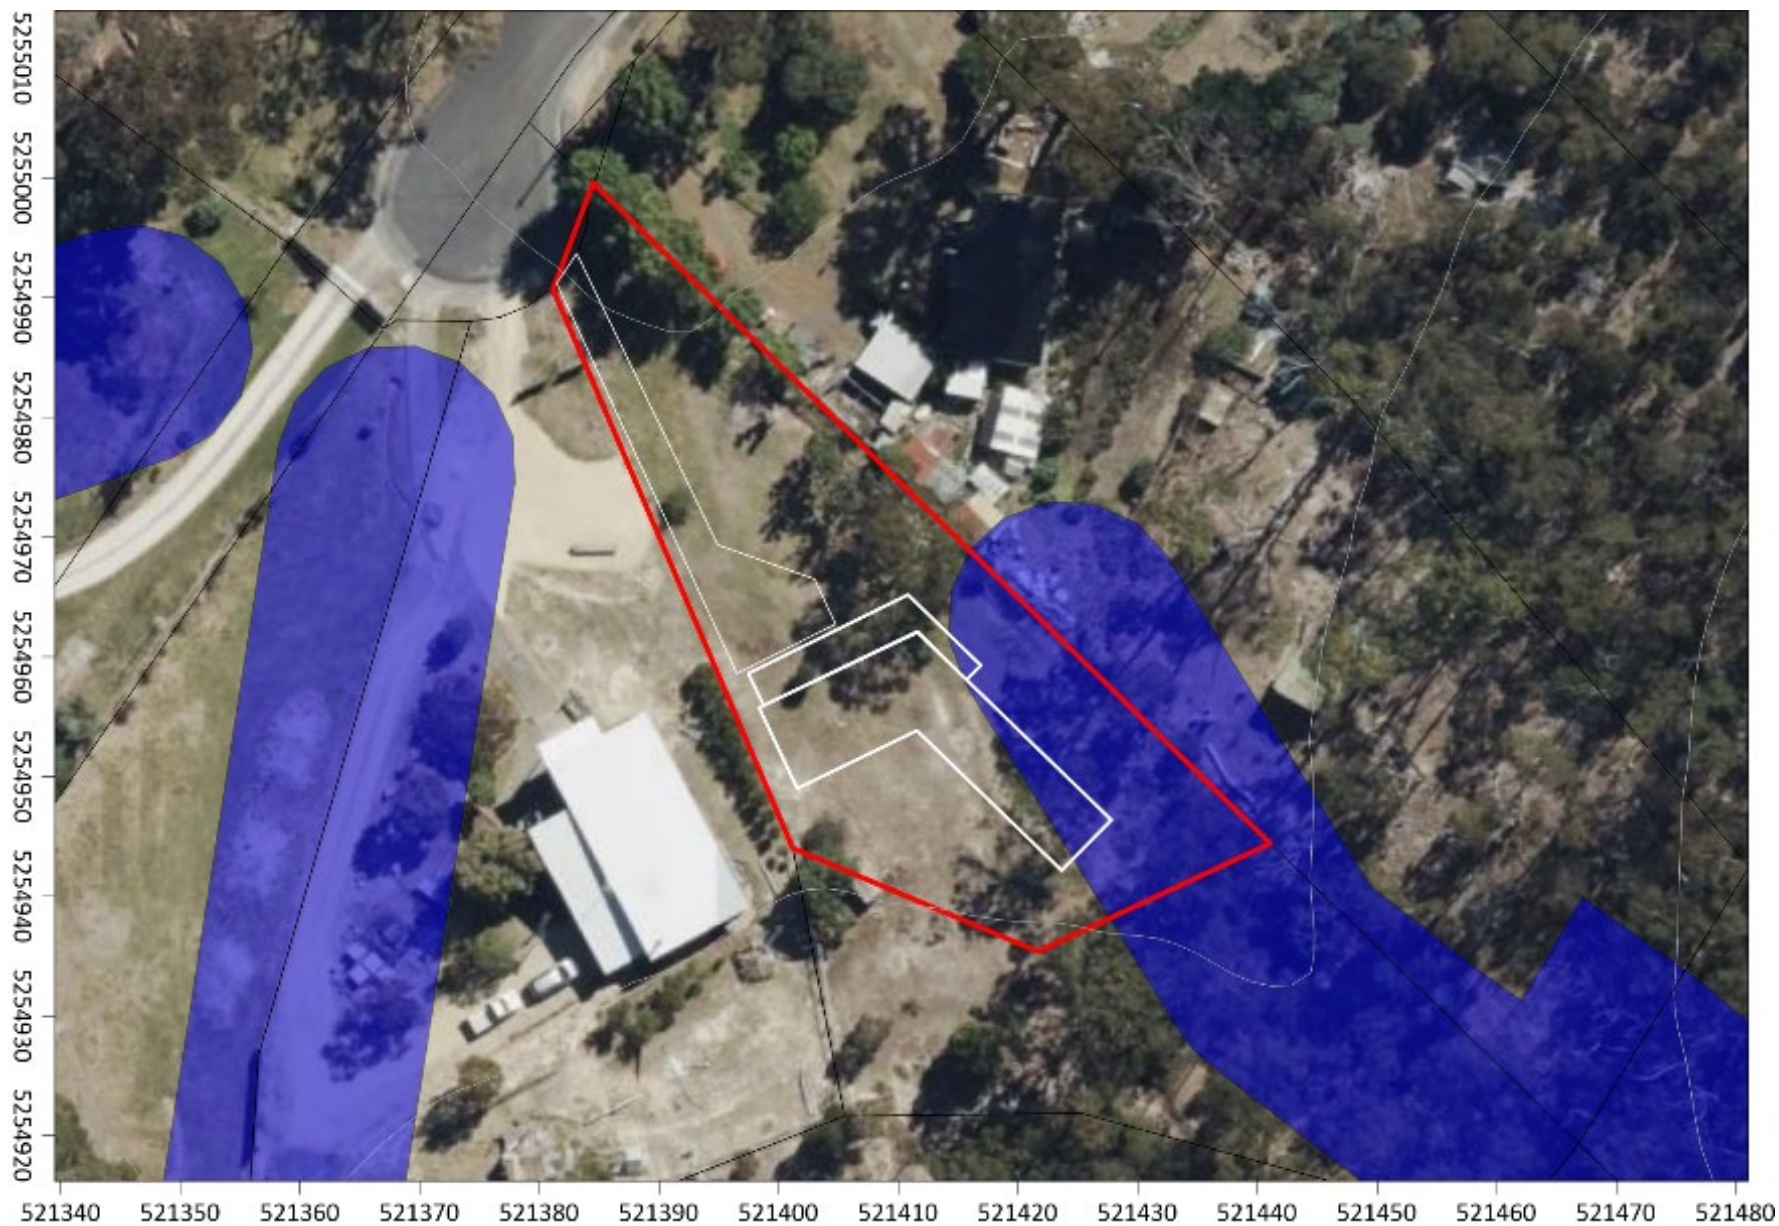
Map 1 Waterways and Coastal Protection Overlay
