DEVELOPMENT APPLICATION

APPLICATION NUMBER:	PLN-25-347
PROPOSED DEVELOPMENT:	Single dwelling
LOCATION:	63 Bimburra Road, Glenorchy
APPLICANT:	Prime Design (Invermay)
ADVERTISING START DATE:	12/12/2025
ADVERTISING EXPIRY DATE:	06/01/2026

Re: Proposed new single dwelling at 63 Bimburra Road, Glenorchy

BUSHFIRE HAZARD REPORT

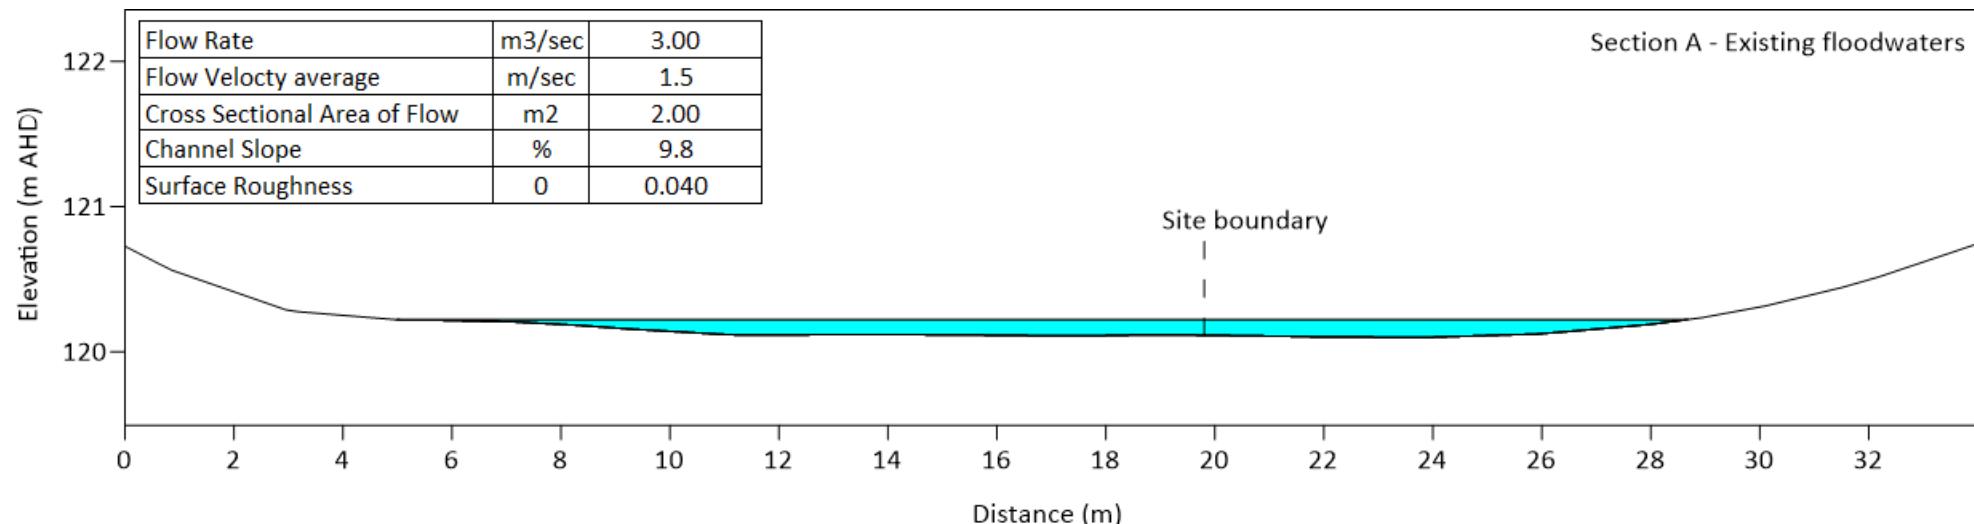
Figure 1 AEP Site Stormwater Flow Analysis – Cross Section A Within the proposed driveway footprint – Drawing Is to Scale and For Conceptual Modelling Purposes Only

This cross-sectional analysis (see Figure 1, Section A – Existing Floodwaters) confirmed a shallow, broad flow path traversing the Site at the driveway entrance. Flow depths were found to be generally less than 200 mm, with no obstructions or modifications to natural flow at this location under current conditions.

- A large upstream catchment (~77 ha) contributes overland flow toward the Site from the south and southwest.
- A cross-section modelled flow of 3.0 m³/s at the driveway, with a channel slope of 9.8% and average flow velocity of 1.5 m/s (Figure 1).

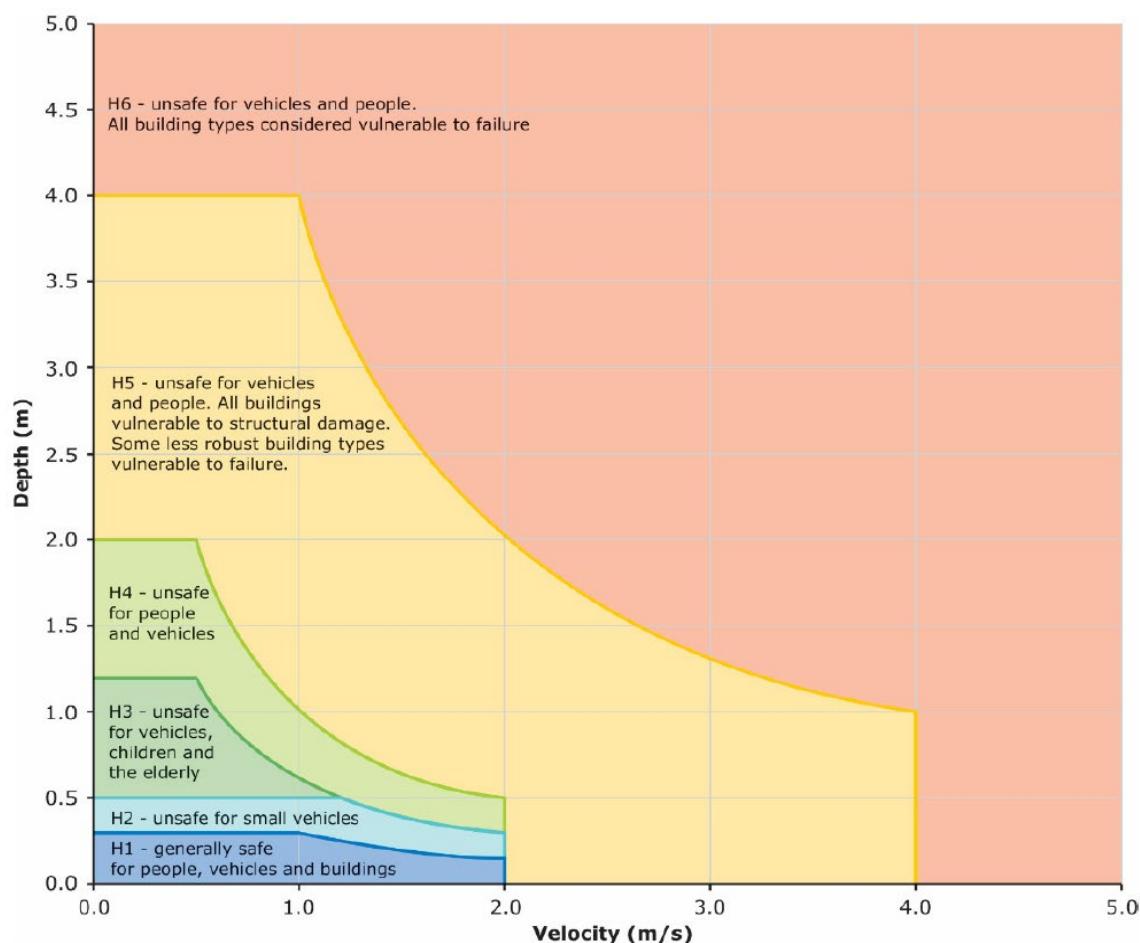
Figure 2 Flood Hazard Curve (Ball, et al., 2019)

Based on the predicted flow depth (~0.2 m) and average velocity (~1.5 m/s), the flood hazard rating affecting the driveway is classified as H1 – generally safe for people, vehicles, and buildings as shown in Figure 2 Flood Hazard Curve (Ball, et al., 2019).

- Based on the modelled flow depth and velocity, the overland flow path at the driveway remains within hazard class H1, considered generally safe for people, vehicles, and buildings (see Figure 2: Flood Hazard Curve).

Consequence/likelihood criteria have assisted in determining if any risk management measures are required at the Site to mitigate any potential hazards. Adopted consequence/likelihood criteria are presented in Figure 2 Flood Hazard Curve (Ball, et al., 2019). Performance criteria are presented in Attachment 6.

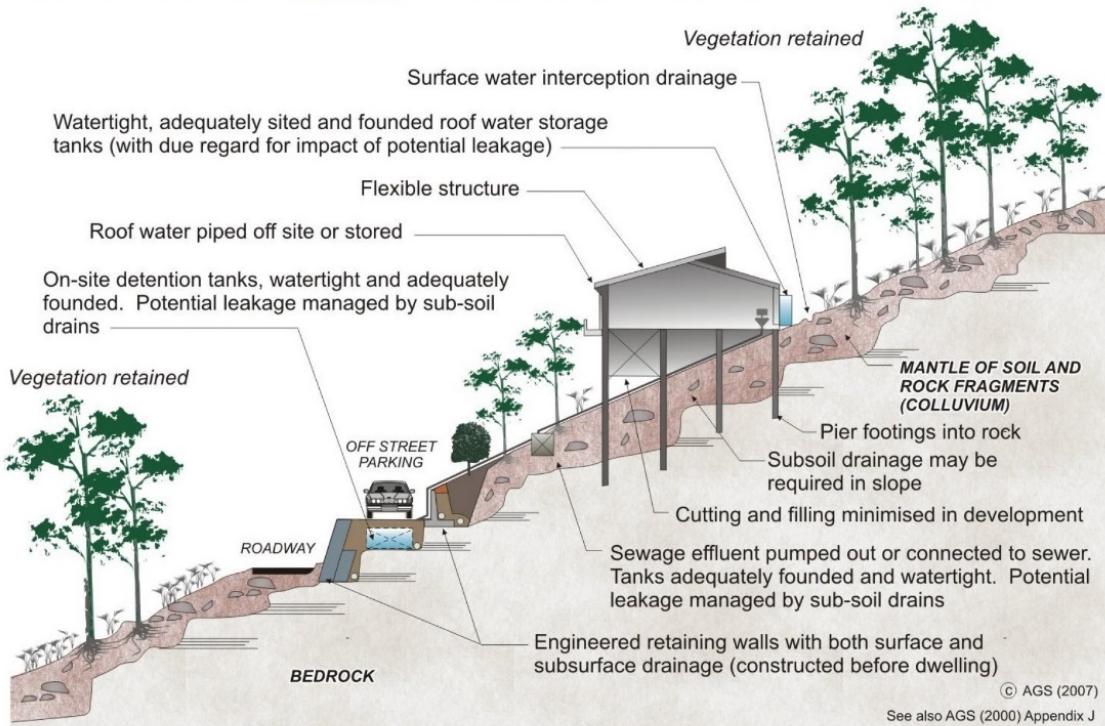
EXAMPLES OF GOOD HILLSIDE CONSTRUCTION PRACTICE

Sensible development practices are required when building on hillsides, particularly if the hillside has more than a low risk of instability (GeoGuide LR7). Only building techniques intended to maintain, or reduce, the overall level of landslide risk should be considered. Examples of good hillside construction practice are illustrated below.

Roadways and parking areas - are paved and incorporate kerbs which prevent water discharging straight into the hillside (GeoGuide LR5).

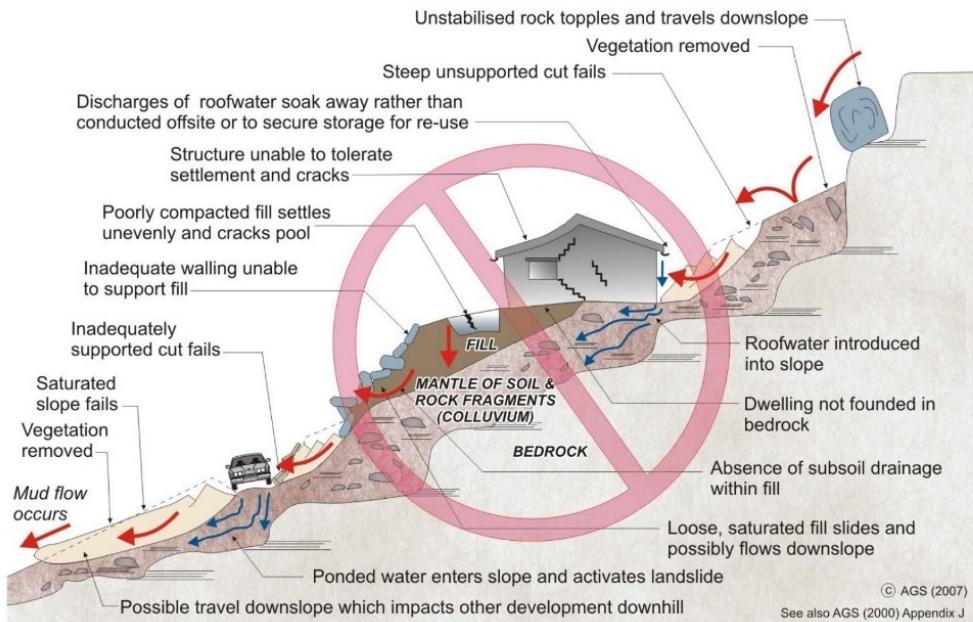
EXAMPLES OF POOR HILLSIDE CONSTRUCTION PRACTICE

Roadways and parking areas - are unsurfaced and lack proper table drains (gutters) causing surface water to pond and soak into the ground.

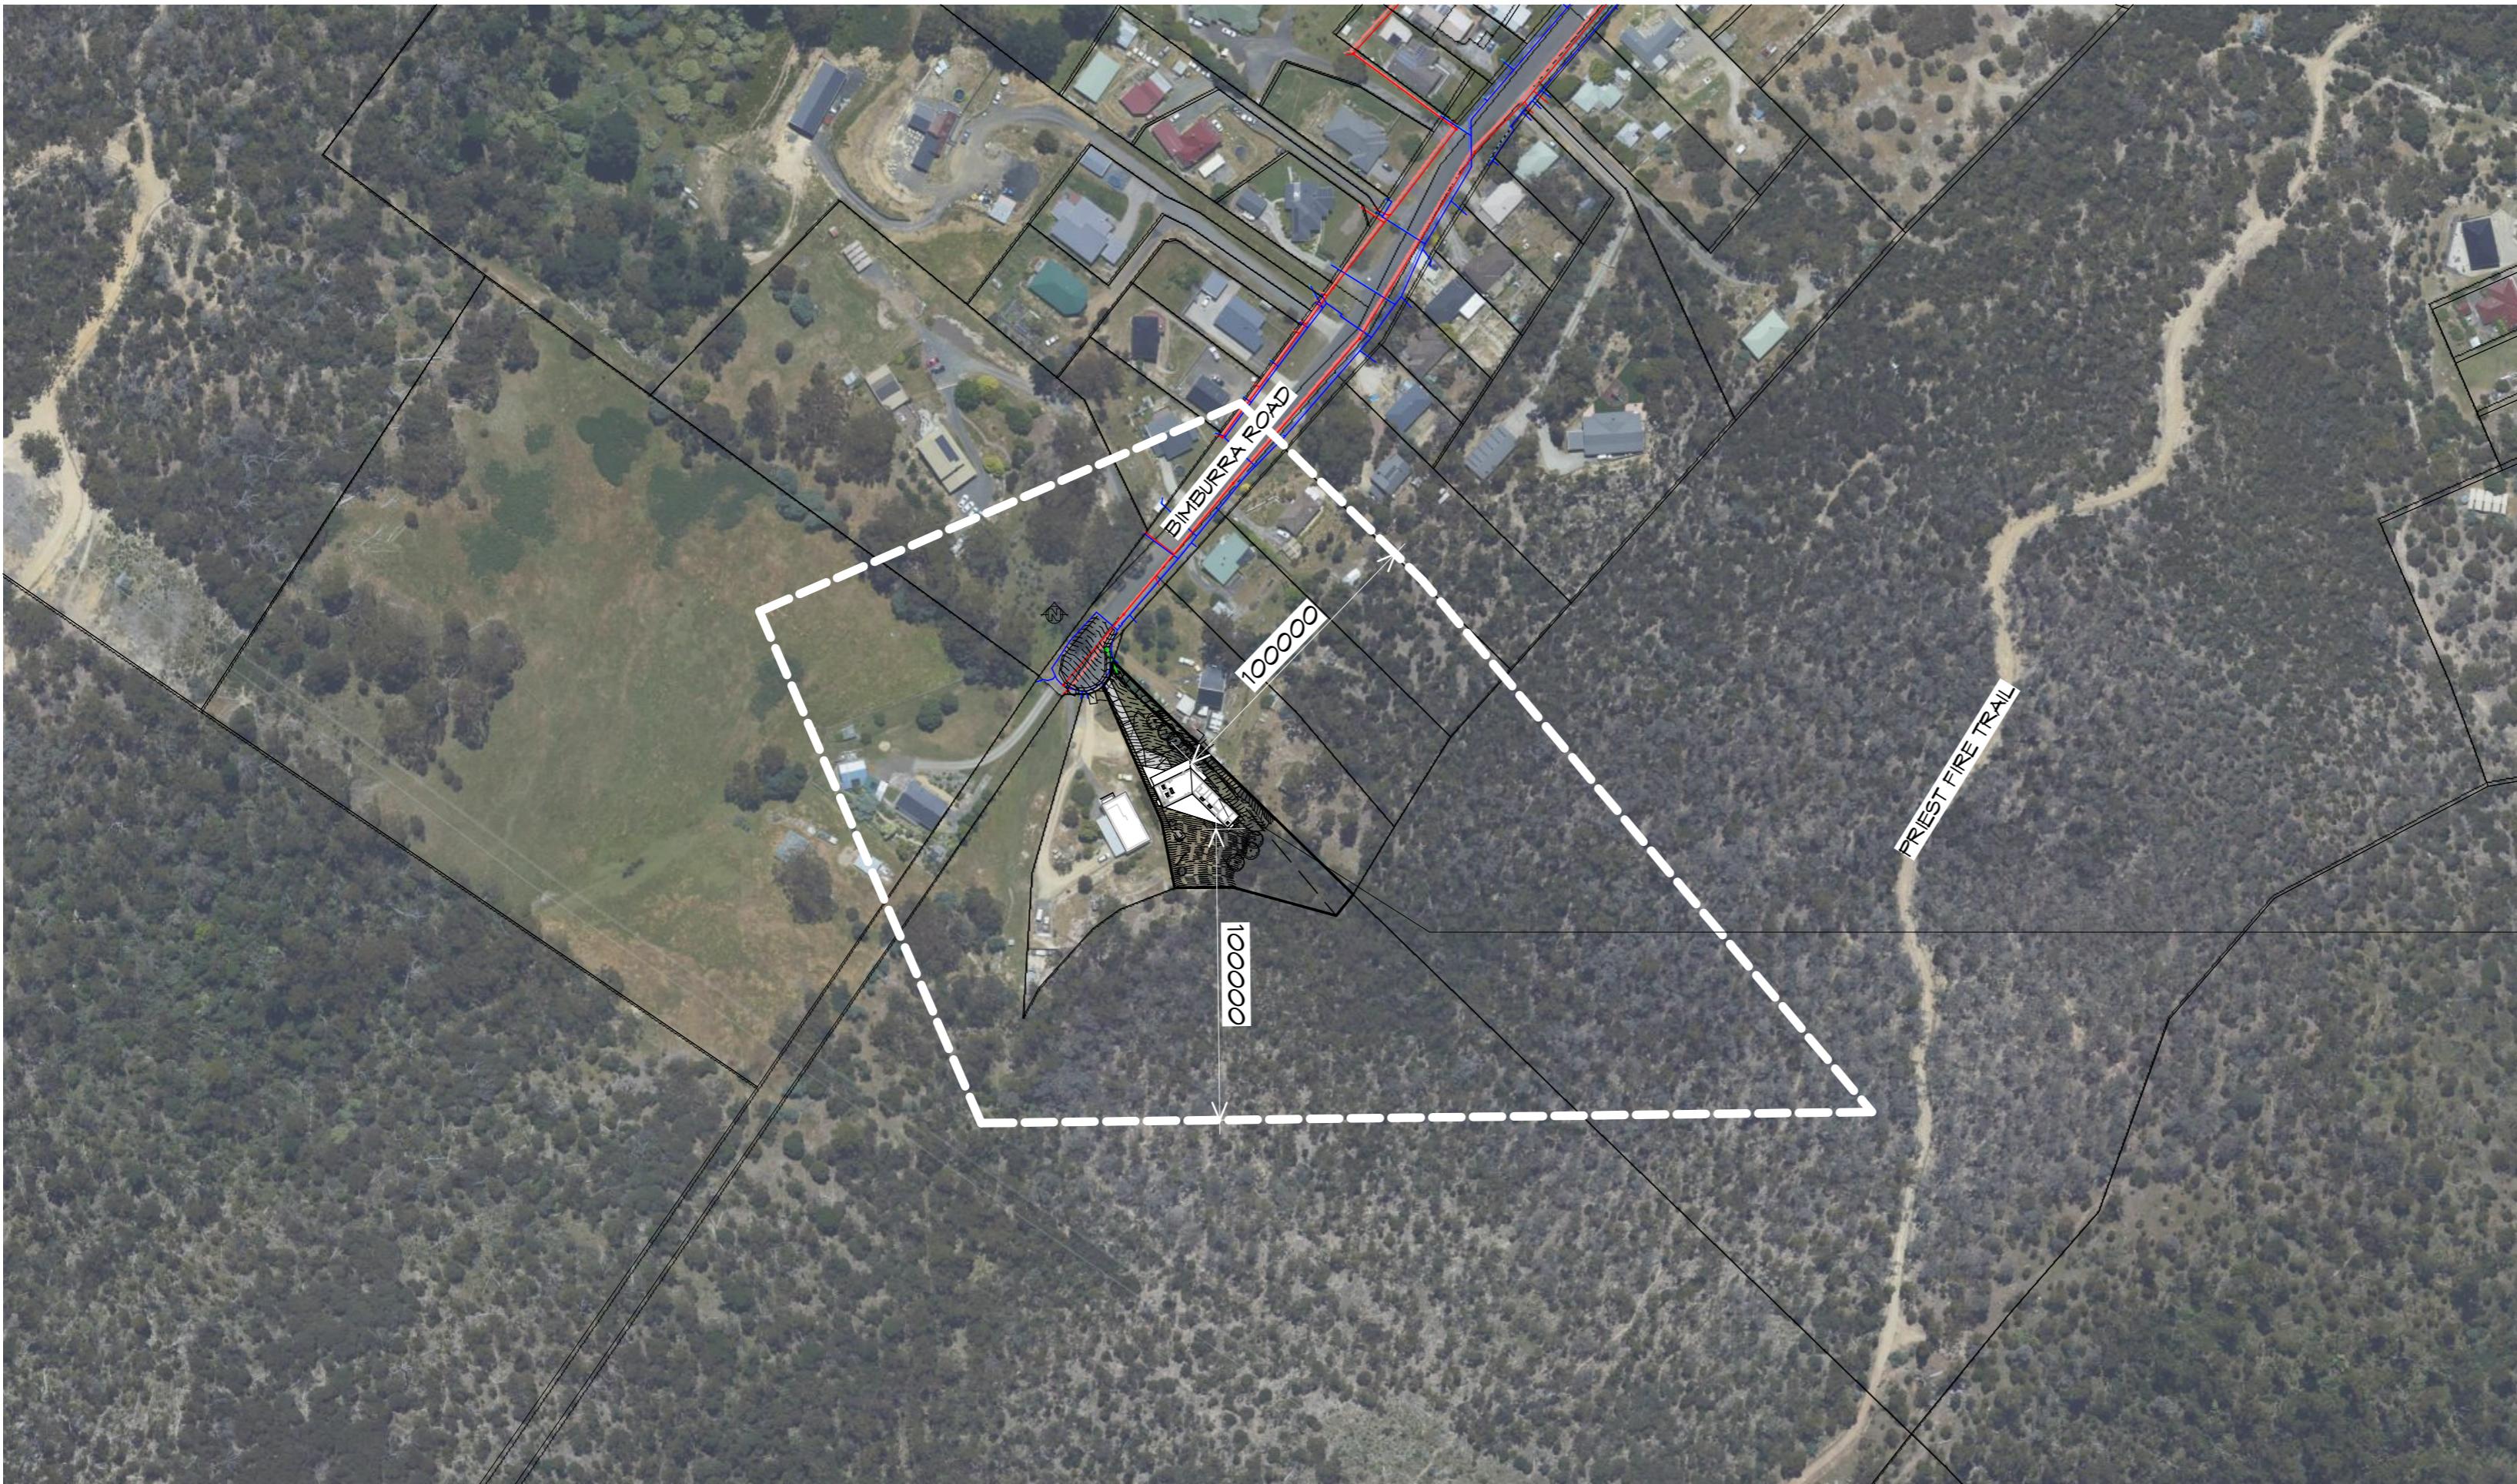
LOCALITY PLAN

THIS SITE IS ZONED LOW DENSITY RESIDENTIAL AND REQUIRES A BUSHFIRE ASSESSMENT.
RESIDENCE IS NOT OVER 100m FROM UNMANAGED BUSH/GRASSLANDS GREATER THAN 1 HECTARE.

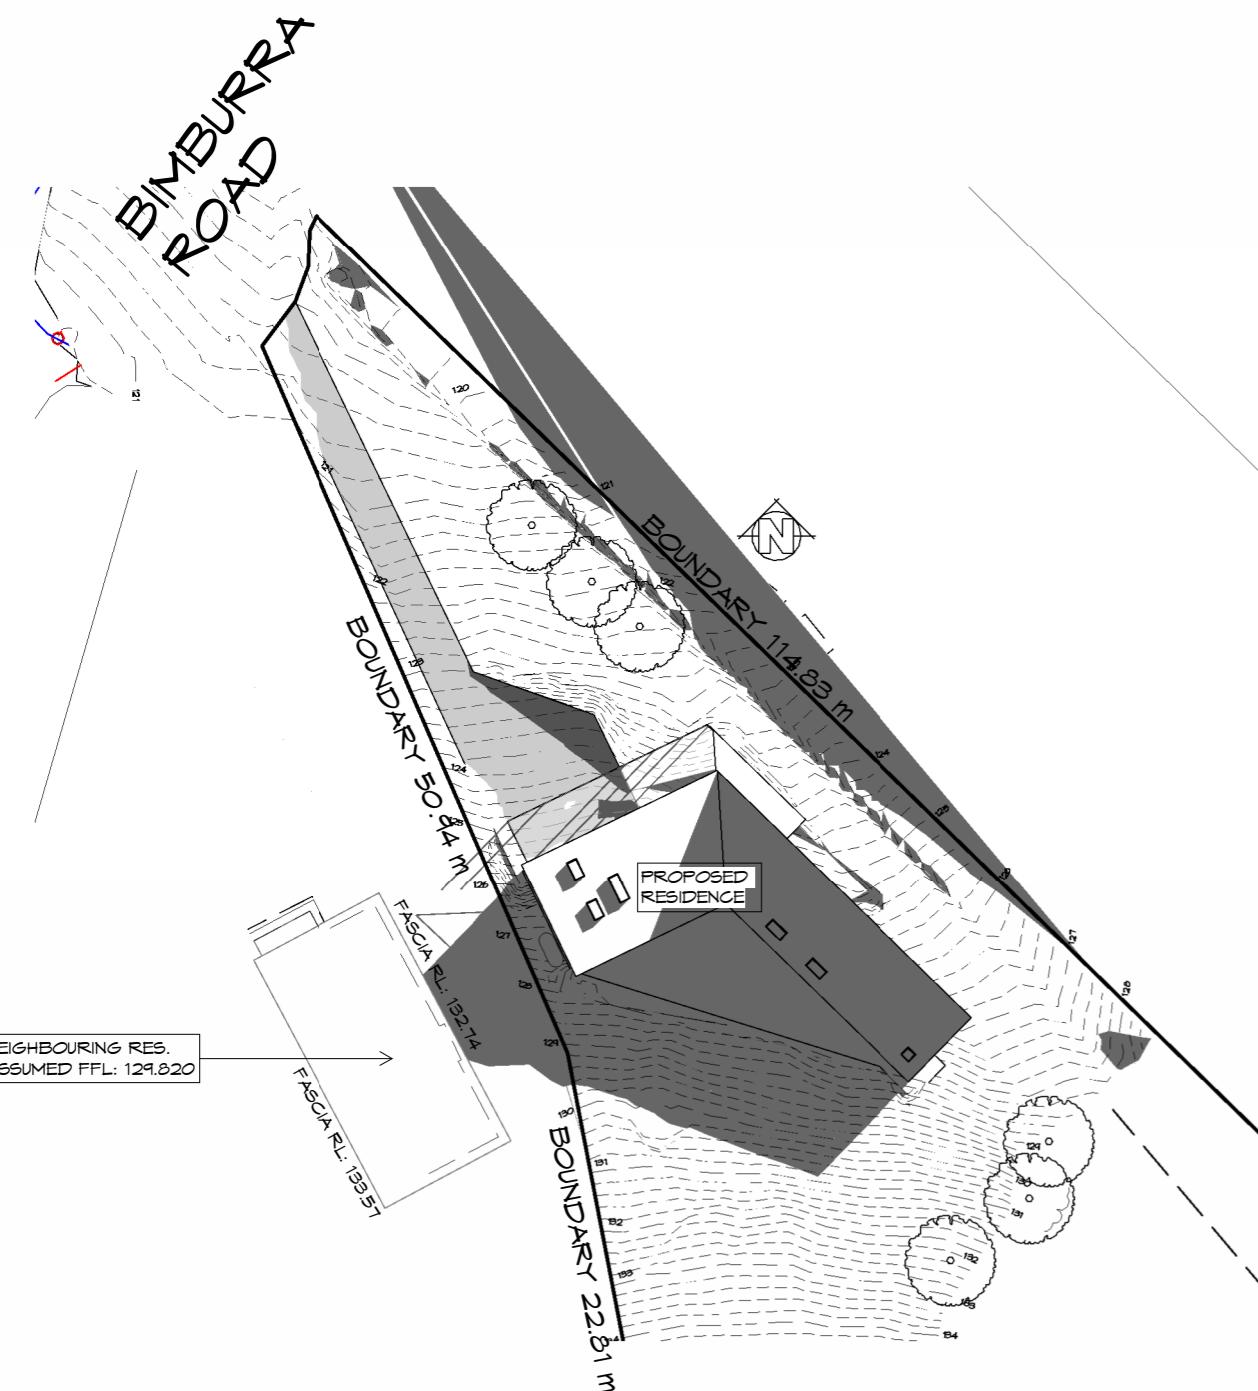
SUN SHADOW DIAGRAM 9AM

GENERAL INFORMATION
NORTH: TRUE NORTH
DAY LIGHT SAVINGS: OFF
DATE: JUNE 21st
TIME: AS INDICATED
